SK® 62TE

Fits: 62TE 2007-17

Corrects / Prevents / Reduces
TCC Slip/Shudder, Overheating, Drainback,
Delay or No Forward or Reverse, Coasting
6-5 UD Apply Clunk or 4-2 L/R Apply Clunk

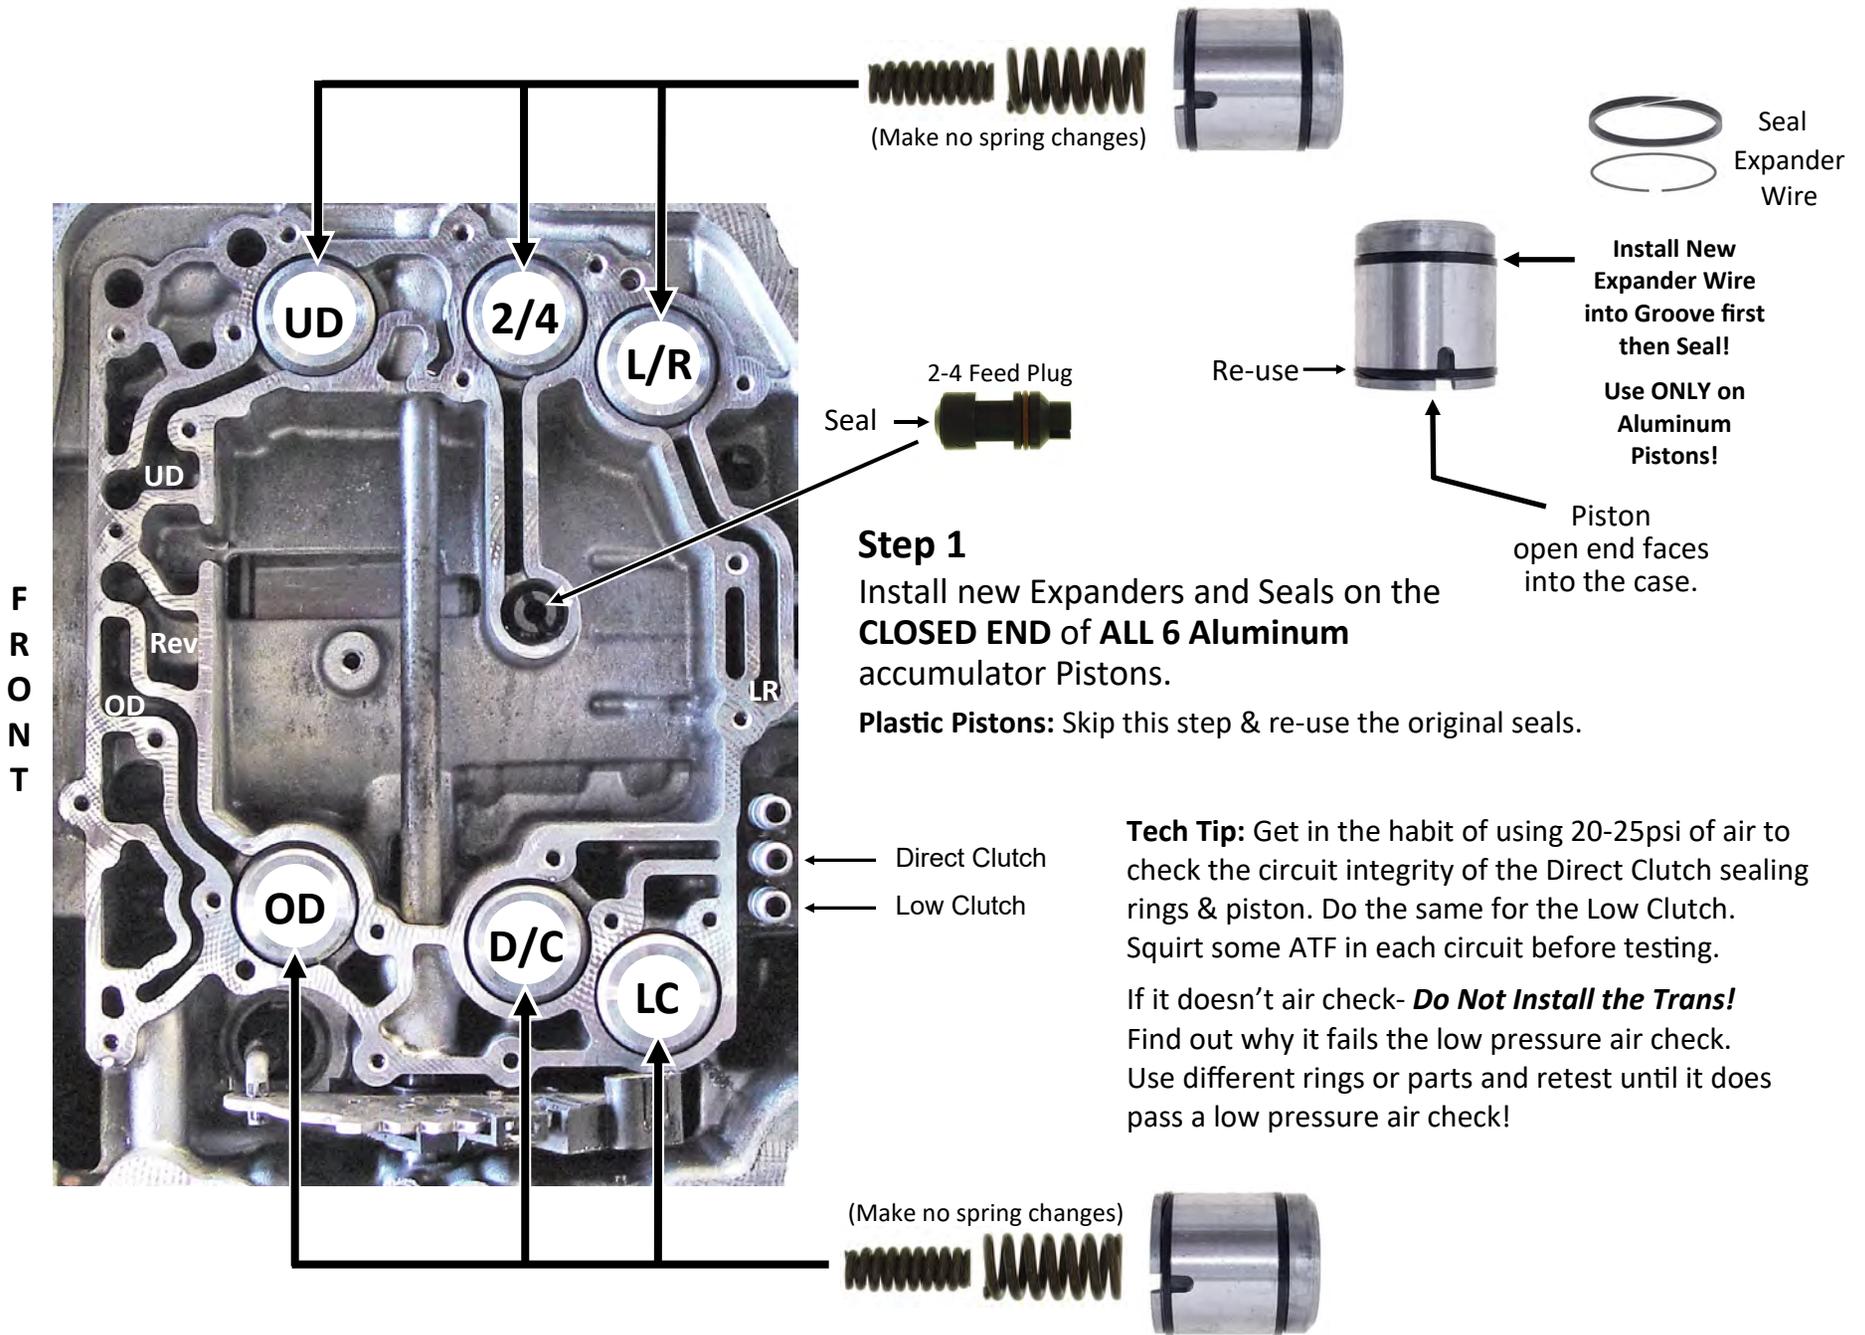
If housing is bent or has damaged holes from over tightening of retaining screws. Replace it!

Plastic Pistons: Skip **Step 1** and re-use the original seals.
 (Plastic Pistons get damaged from spring contact. Look inside where springs touch.)

Discard OE L/R Housing Gasket. Install new **Non Shrinking Gasket** under Piston Housing. Gasket works great with all L/R piston housings.

Install New **Non Shrinking** Gasket.

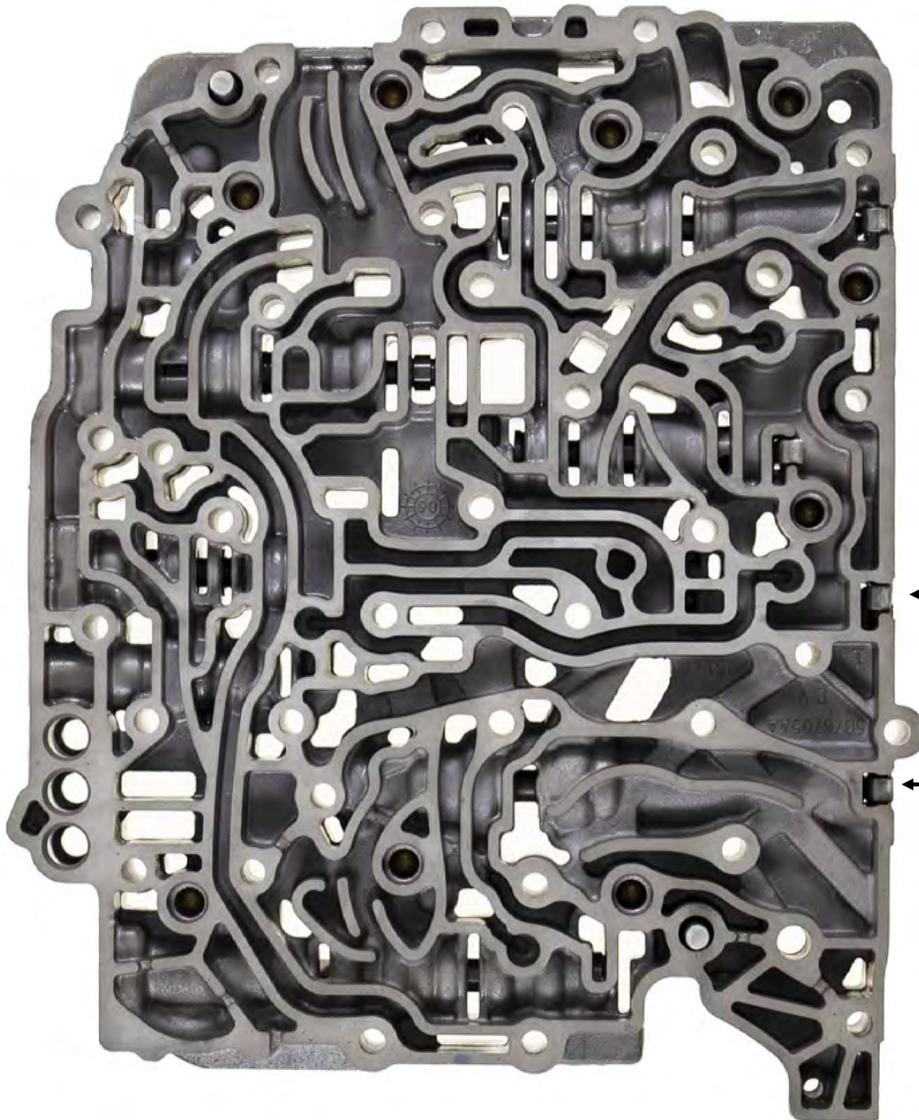
Valve Body Repairs

The repair work on this page will improve the overall **stability** of the **main pressure system** to **reduce shift complaints** as well as **correct** the malfunctioning Torque Converter Regulator to **improve** lubrication, cooling and **prevent** drainback from bore wear. An easy and effective **drop-in** solution. Saves **\$\$\$** and time. We love it! You and your customer will too.

Step 1.

Install **New TC Regulator Valve** checking that it travels freely then **New Orange Spring & reuse retainer**.

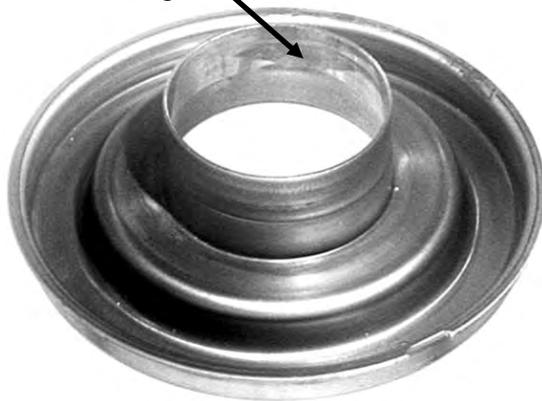
Close inspection of Underdrive piston bore will often show wear and a ridge where the piston has rubbed against the seal groove in the input hub. This ridge nibbles the seal and the wear causes a cold leak.

With a worn piston or a cut seal there will be a delay or no forward cold and sometimes limp-in on cold startup into drive until the seal warms and becomes more pliable.

Also, during a long run in 4th the seal relaxes and can fail to re-seal quickly on a 4-3 coast downshift between 28 and 19mph. The computer sees the delayed apply by watching the speed sensors and places trans in limp.

Inspect piston here for wear and ridge.

A temporary solution is a new piston. A better fix is to install this quality self expanding seal that is pliable enough to seal into worn area and tough enough that the ridge won't cut it. Install it with confidence.

PLEASE: Don't hone, sand, scrape, polish or try to fix the piston in anyway. Leave it as-is. If it's really bad, replace it and use the new expander & seal for a long term fix.

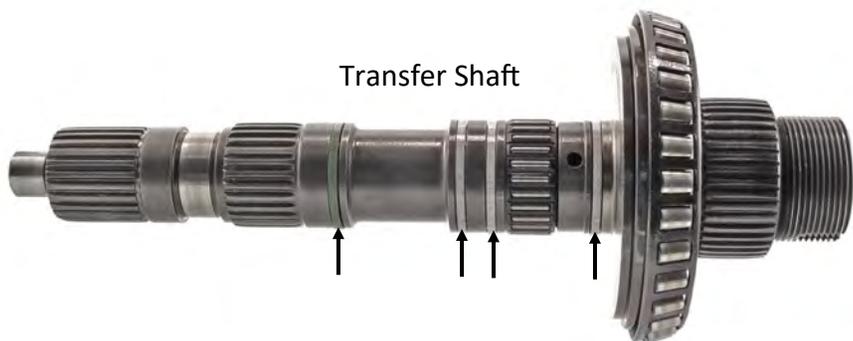
These 4 rings like to shrink dumping lube oil that can lower main line and accelerate ring land wear on the low clutch housing. 68018615AA

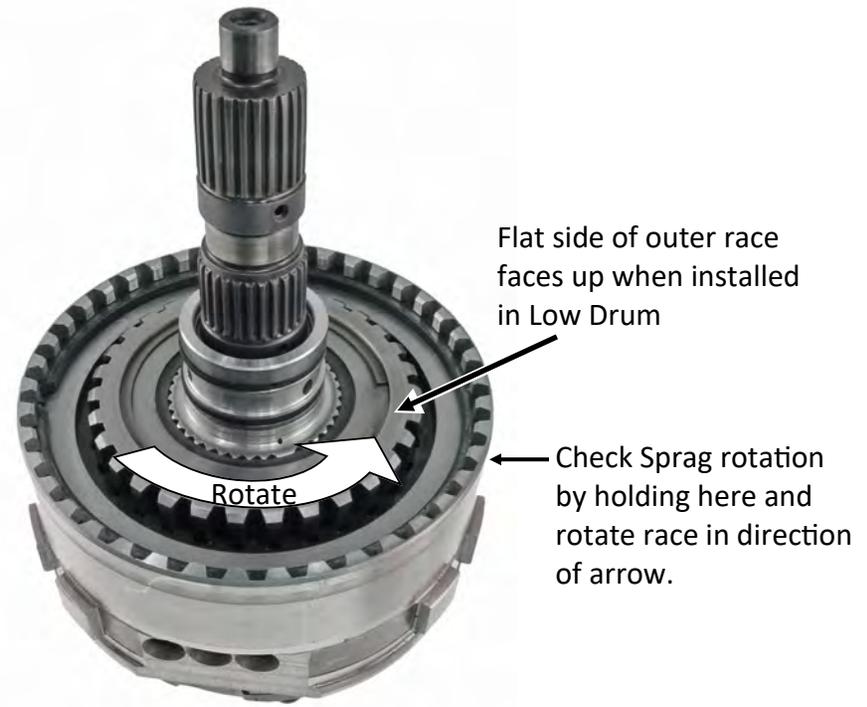
Early rotating rings usually destroy the ring grooves on low clutch housing. Later housings are notched for non rotating rings 05078800AB OE rings air check great and work excellent in these notched housings. 20-25 psi of regulated air must apply direct clutches on the bench, don't assemble unit until they do!

Updating the Low Clutch Housing to the latest Non-Rotating Ring type housing during overhaul is an great way to prevent rework due to ring groove damage. Even though it may not be damaged at time of overhaul, be warned, it does have a known high failure rate. Remember the customer pays for the parts now, you have to pay for them later.

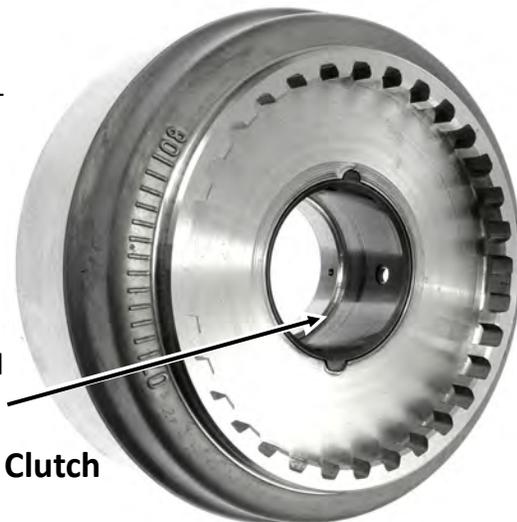
Compounder Wear Areas

Loss of lube from shrunk sealing rings on the transfer shaft will accelerate wear on the ring tower causing Direct Drum rings to leak.

With severe wear, the top sealing ring may be found still in the drum here.
