SK[®] 604 Shift Kit[®]

604/41TE & 606/42LE 1989-2013

Also fits 42RLE 2003-2011

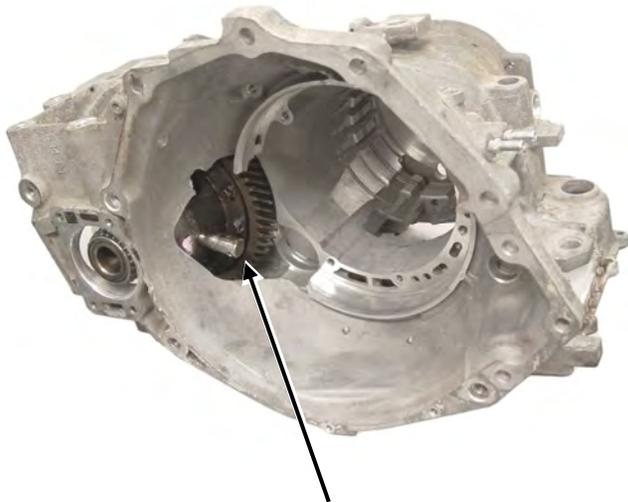
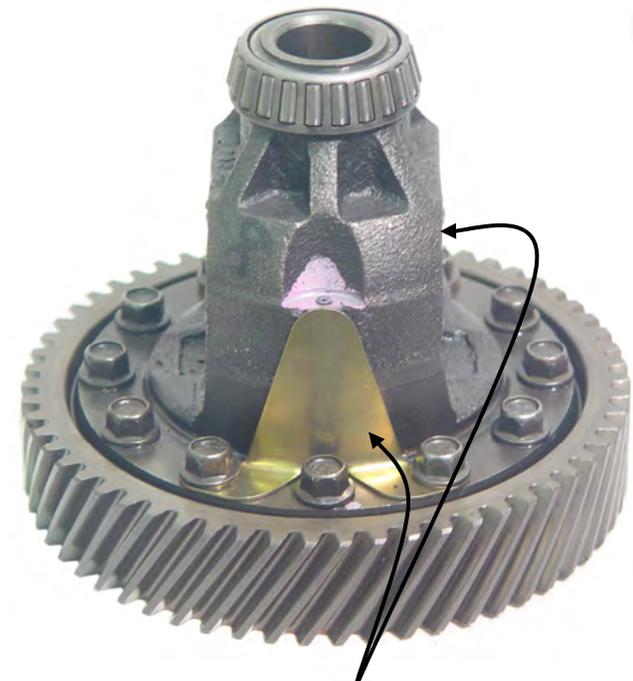
604-CB Case Damage Brackets

Prevents differential pin from sliding out and destroying case.

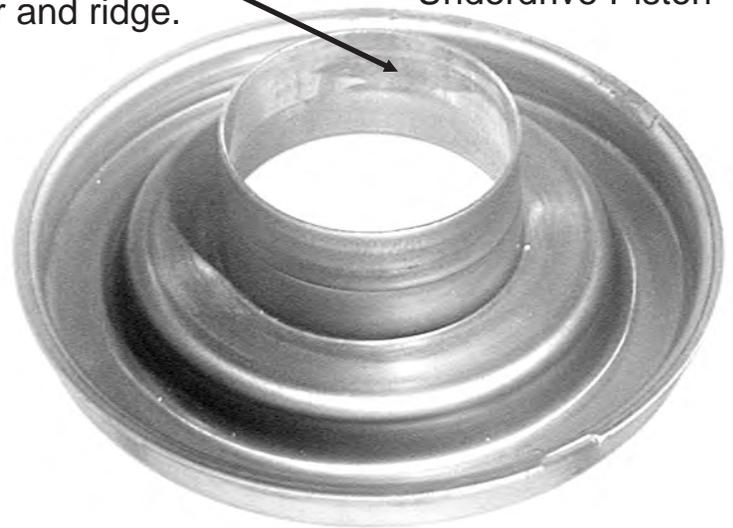
Underdrive Piston

Inspect piston here for wear and ridge.

Close inspection of underdrive piston bore will show wear and a ridge where the piston has rubbed against the seal groove in the input hub. This ridge nibbles the seal and the wear causes cold leak.

PLEASE: Don't hone, sand, scrap, polish or try to fix the piston in any way. Just leave it like it is and install the seal. It'll work just fine.

A temporary solution is a new piston for \$27. A better fix is a quality self expanding seal that is pliable enough to seal into worn area and tough enough that the ridge won't cut it.

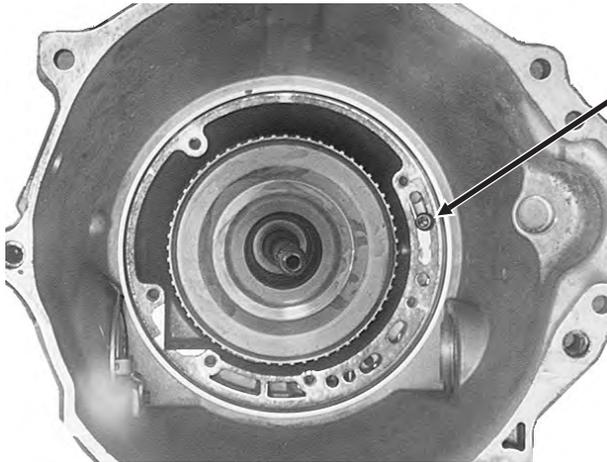
Cooler Bypass Valve

If the case has a 2" deep hole here it **MUST HAVE** a cooler bypass valve installed. Less than 1" no bypass valve.

Check bypass valve: Mouth blow on o'ring end of cooler bypass valve, it must be air tight. If the valve is not air tight replace it #4539880.

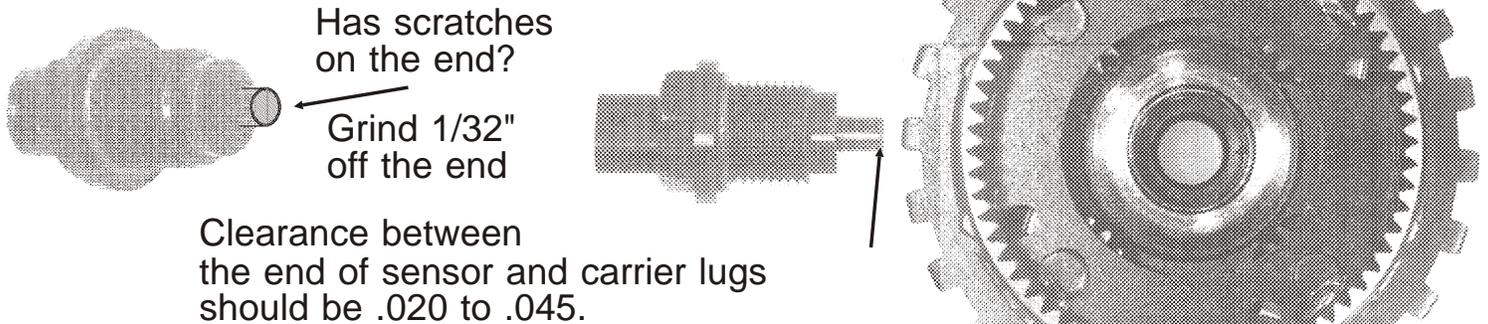
Look carefully at the end of the sensors. If there are scratches on the magnet it is rubbing. If it has scratches grind end shorter prox .032. A new sensor may also rub and need grinding.
