**Toyota U140 E&F 4 speeds:**

**Toyota U240 & U241 4 speeds:**

# Accumulator Body Repair

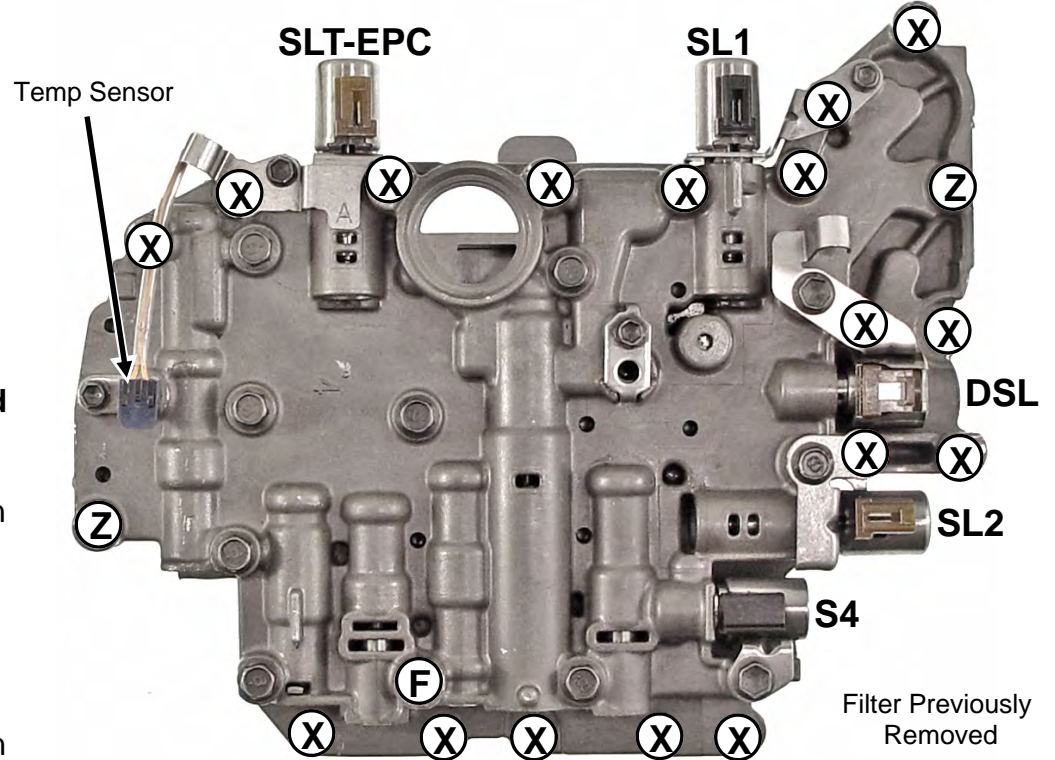
**Step 1**

Remove the "X" & "Z" bolts that hold the VB to the case. When reinstalling VB, install "Z" bolts first. They align the VB to the case. Disconnect wiring. The "F" Bolt holds filter to VB. Remove it & Filter as well. Keep these bolts separate from the rest of the VB bolts.

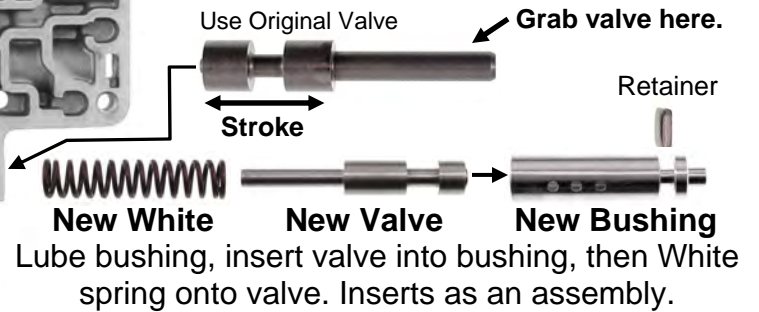
**Preassembly Check**— Clean new valve and bushing. Insert new valve into bushing and look for chips in drilled holes. Clean as necessary. We have gone to great lengths to remove them but occasionally one sneaks by.
