# 6L8-VL-PR3 Patent Pending Fixes 3 Transmissions

## Corrects/Prevents/Reduces

Extreme Pressure Damage Due to Worn PR Bore,  
Restores Proper Pressure Regulator Function.  
No Special Tools Required!

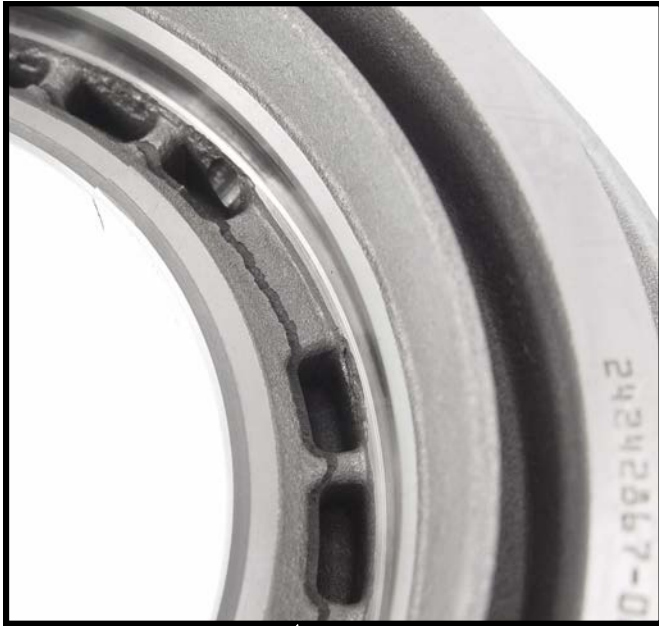
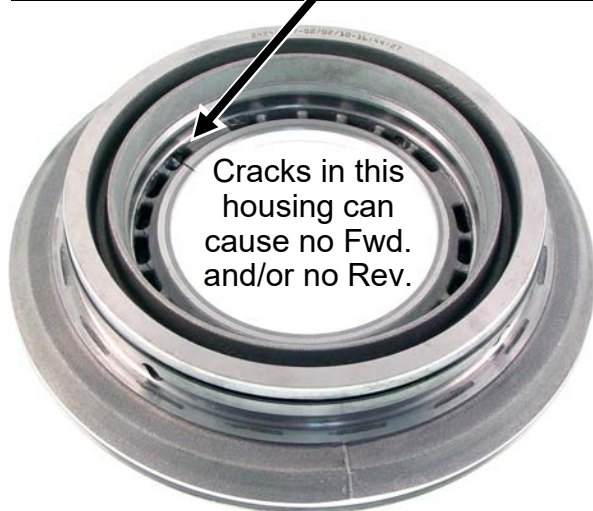
1-2-3-4 Clutch Housing

The blowouts are easy to see.

What breaks depends on what gear the trans was in when the extreme pressure malfunction occurs. The 1-2-3-4 clutch area shown is one of the more common areas to fail due to extreme pressure.

Complaints can be no 3rd, 5th, Reverse, Forward or falls out of gear at a stop when hot.

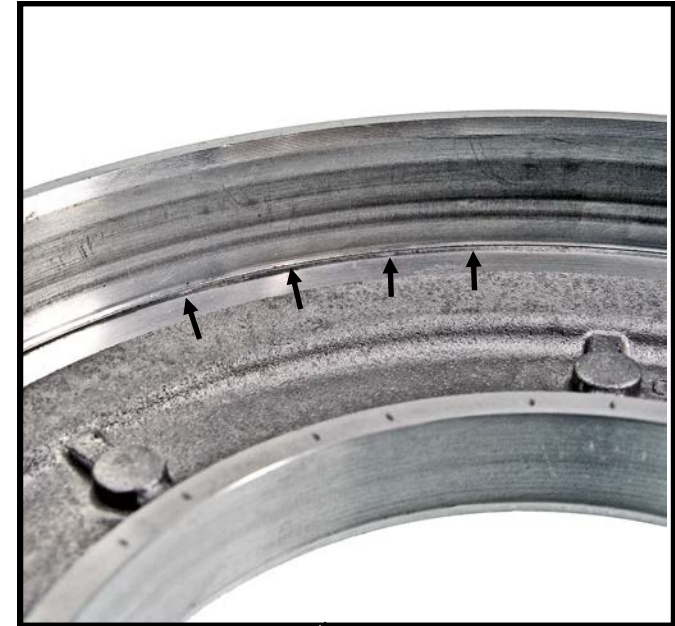
Look Carefully for Hairline Cracks

**Wash parts and blow dry with compressed air before looking for cracks! Keep a magnifying glass handy if you have less than youthful eyes!**

**WARNING! When replacing pistons and related parts, MAKE SURE they are the same diameter as parts your replacing. Differences can be as little as .045"!**

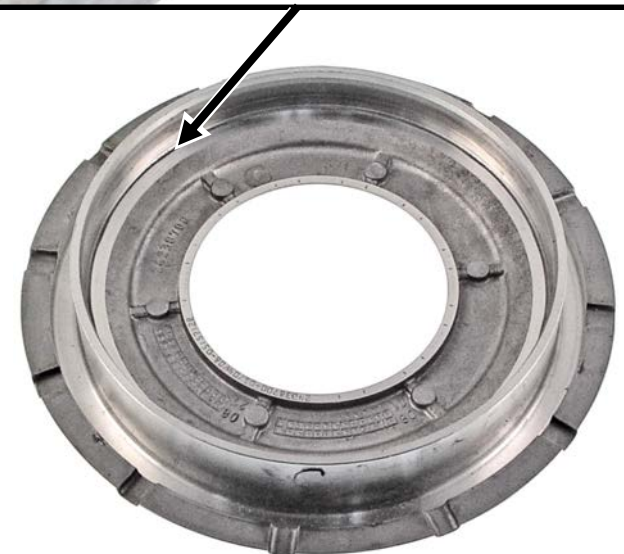
1-2-3-4 Clutch Piston

**LOOK CAREFULLY!**

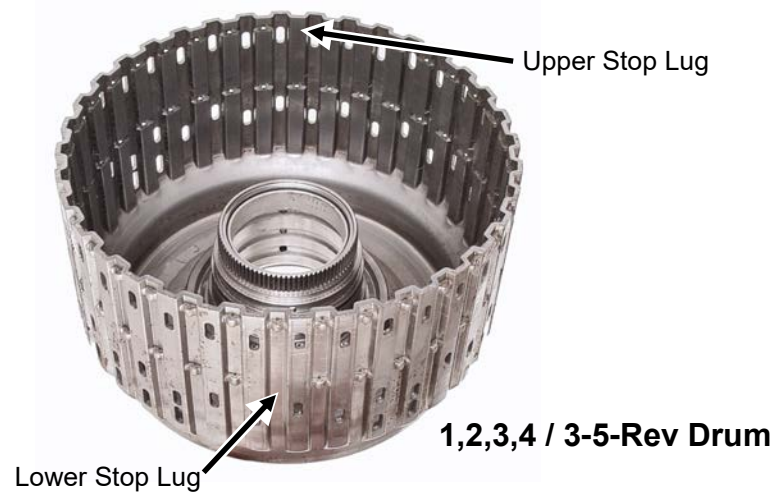
### 1,2,3,4 / 3-5-Rev Drum

Pay attention to the location of the Lower & Upper Snap-ring **Stop Lug** in the Drum. The **open ends** of each snap-ring **MUST** be located on either side of the lug. The lower and upper stops are located 180° opposite of each other in the drum.  
(Lug has no groove for snap-ring!)

If mislocated, it may take as much as 3 weeks for the snap-ring to become dislodged & set solenoid performance codes. This is usually but not limited to complaints of no forward and or no reverse **after overhaul**.

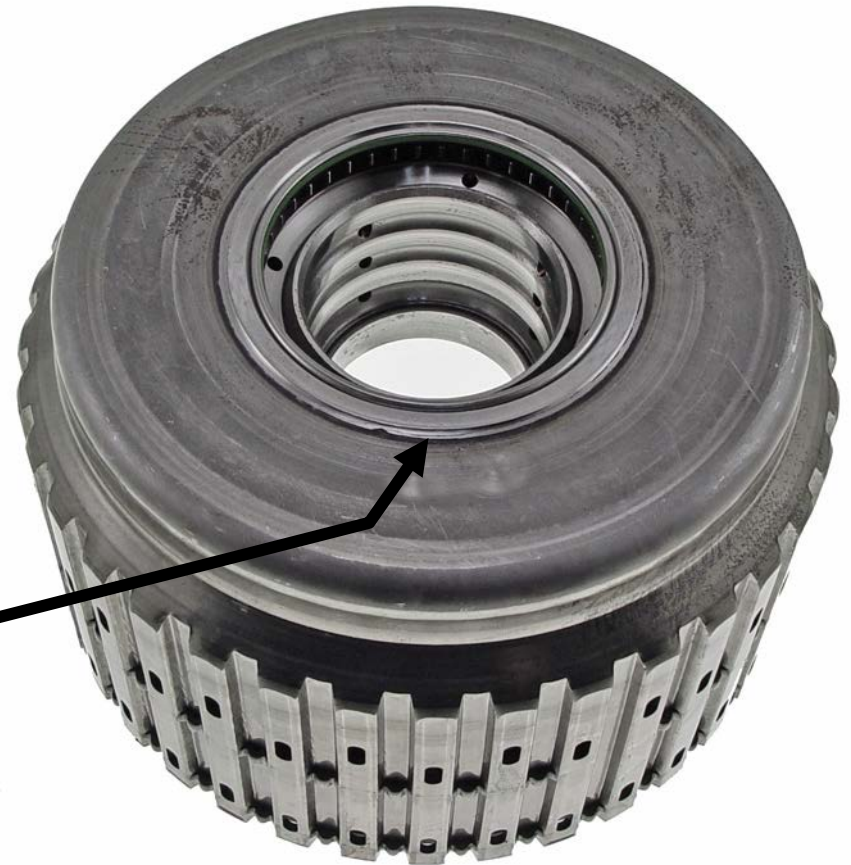
1,2,3,4 / 3-5-Rev Drum

Look carefully for hairline cracks on the front of the drum! Hold it! You may need a magnifying glass to see the crack. At this time a loaded drum complete is approx \$285.00. In our opinion if the clutches were damaged or the vehicle had a Forward, 3rd, 5th or Reverse complaint, it's far safer to replace the drum as an assembly then risk the re-work.

High torque transfer or shift shock can damage the drum but not crack the pistons. However, it's the high pressure that can damage both the drum and or the pistons. Fixing the extreme runaway pressure is key to keeping the parts alive longer.
