Front Servo Piston Cover Kit

22827-01

Chrysler 46RE, 46RH, 47RE, 47RH, 48RE, A727

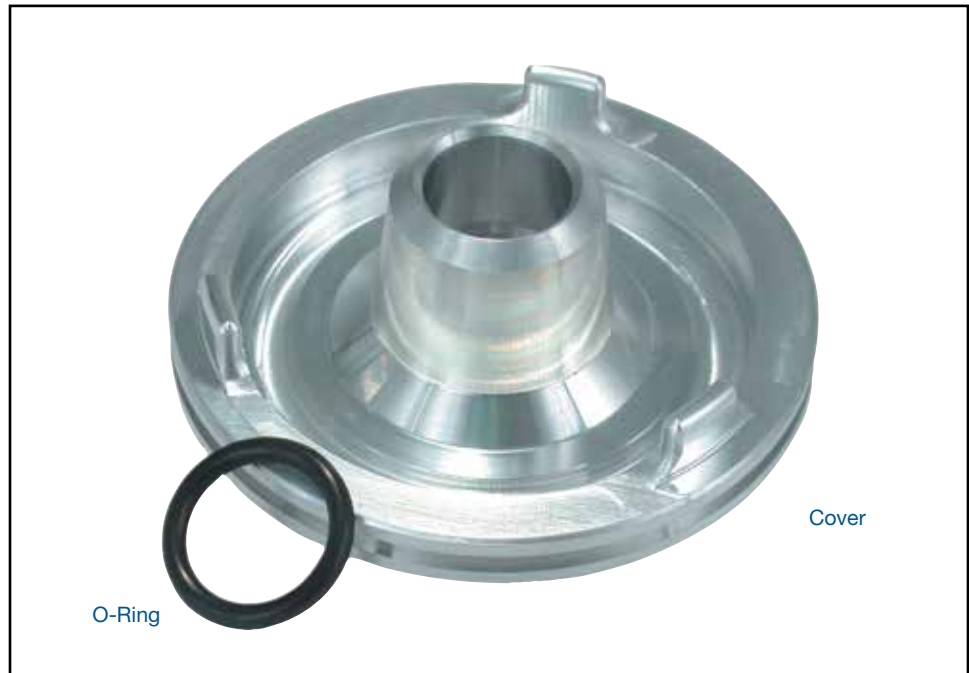
- Cover
- O-Ring

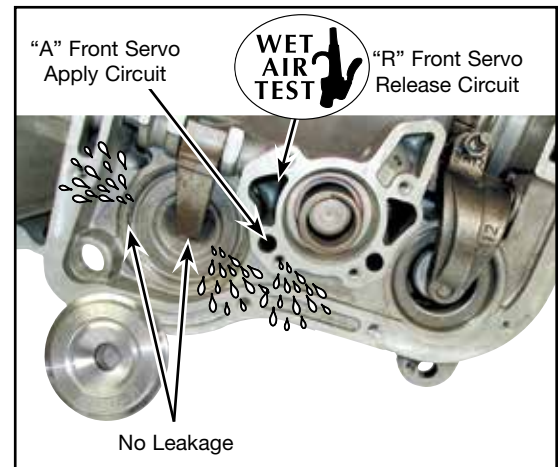
- Place a small amount of oil into the front servo release port "R" and follow with 30-40 psi of air pressure.
- Verify that there is no leakage at the servo cover.
- Oil leaking into the servo apply circuit indicates cross leakage at the servo piston. This means lost clutch oil and can result in direct clutch failure.
