# COOLMASTER

## Fitting Instructions

Part № **49469K**

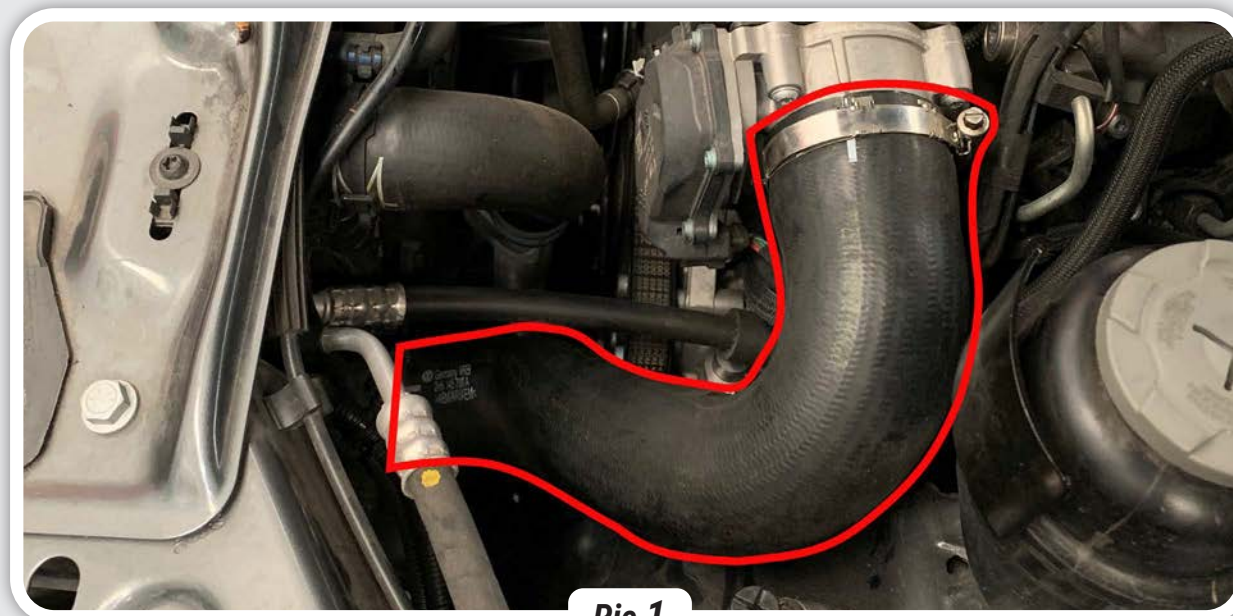
1. Open bonnet.
2. Remove engine cover (if fitted) and then locate and remove the air intake pipe between intercooler and throttle body. Cover intake openings to prevent foreign objects falling into openings. **(Pic 1)**

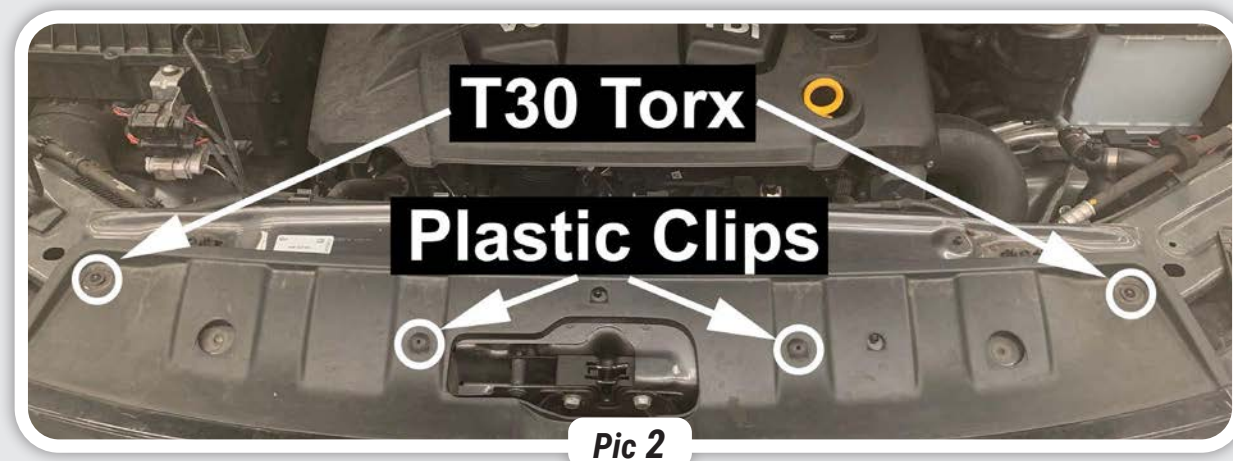
3. Remove the two (2) T30 torx screws from the outer edge of the radiator shroud and the two (2) plastic clips towards the inside edge. **(Pic 2)**

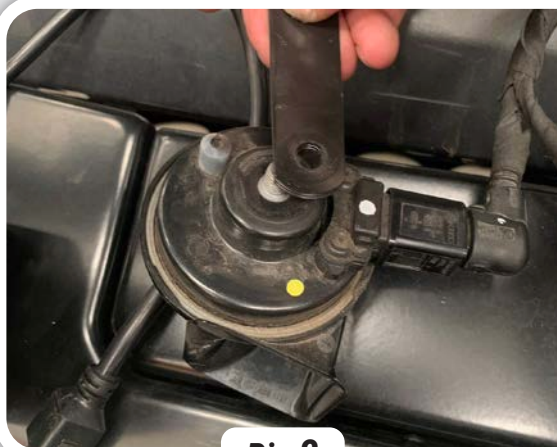
**Pic 3**

6. Remove horns from mounting brackets by removing the nuts and washers holding each horn. Save hardware for later use. **(Pic 3)**

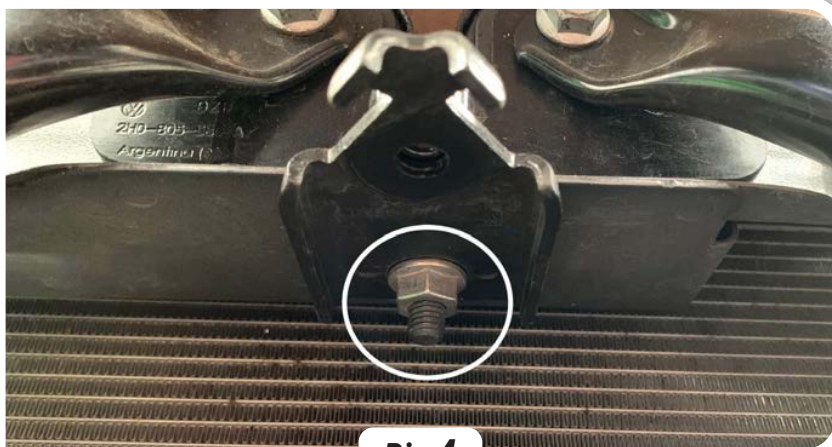
**Pic 4**

7. Remove the 13mm nut holding the horn bracket assembly from underneath the horn bracket. **(Pic 4)**
8. Loosen the two (2) bonnet catch bolts holding the top of the diagonal brace bars to give approx 6mm gap. **(Pic 5)**
9. Fit the supplied cooler hose to the two fittings on the cooler and secure with two (2) hose clamps. Do not cut the looped end yet.

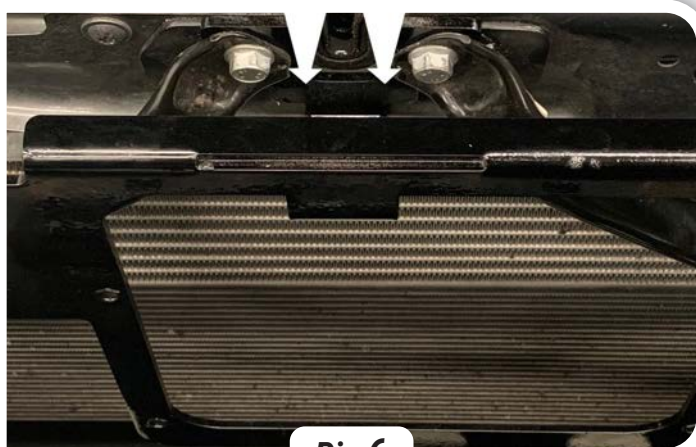
**Pic 6**

10. Lower the cooler bracket into place and slide the two (2) upper mounting wings behind the diagonal brace bars. **(Pic 6)**

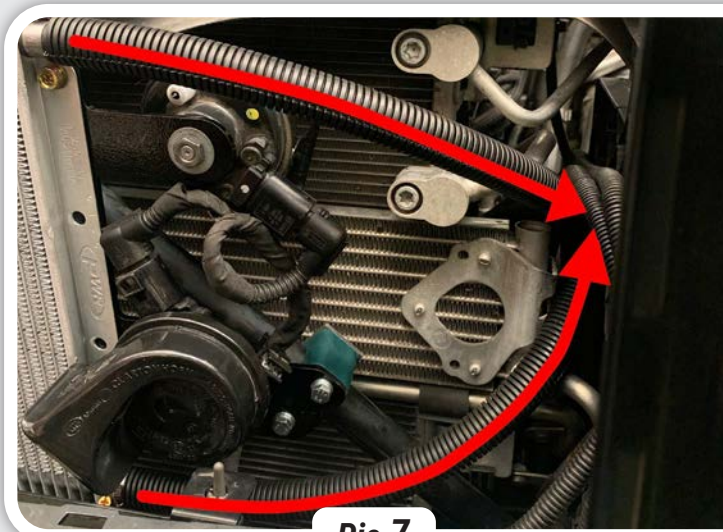
**Pic 7**

- 11.** Route cooler hoses through gap beside radiator on passenger side. **(Pic 7)**

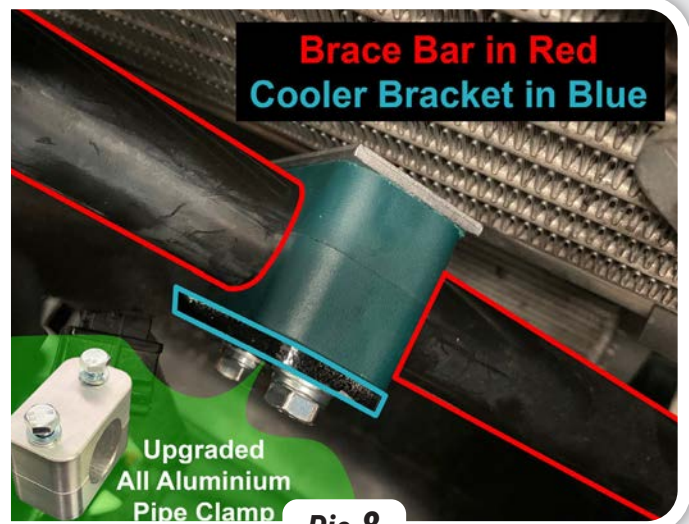
**Pic 8**

Remove the two (2) bolts and washers from the upgraded pipe clamp. Place the non threaded clamp half between the cooler bracket and the brace bar and feed the two (2) bolts and washers through to hold in place.

Place the pipe clamp half with the threaded holes behind the brace bar and screw the two (2) bolts into the threaded half. **(Pic 8)**

- 12.** *\*\*We have upgraded the pipe clamp to an all aluminium two piece clamp to aid fitting in the tight space behind the brace bar. The second half of the clamp is threaded which means we no longer require the seperate plate.\*\**

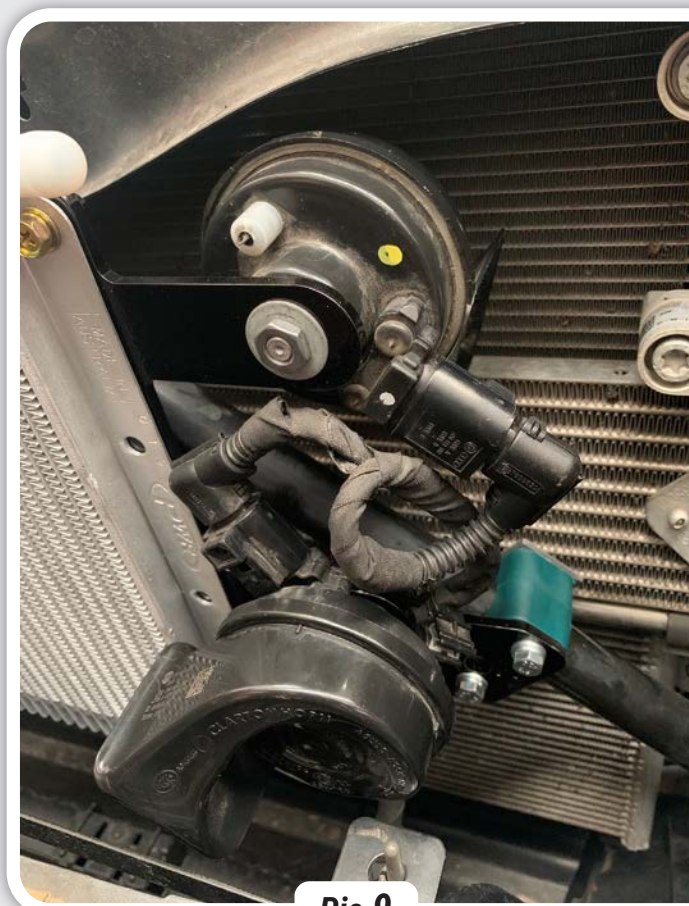
**Pic 9**

- 13.** Mount horns to cooler bracket using original hardware. Upper horn mounts facing rearwards, lower horn mounts facing forwards. Ensure the orientation of both horns are facing downwards to avoid water ingress. **(Pic 9)**

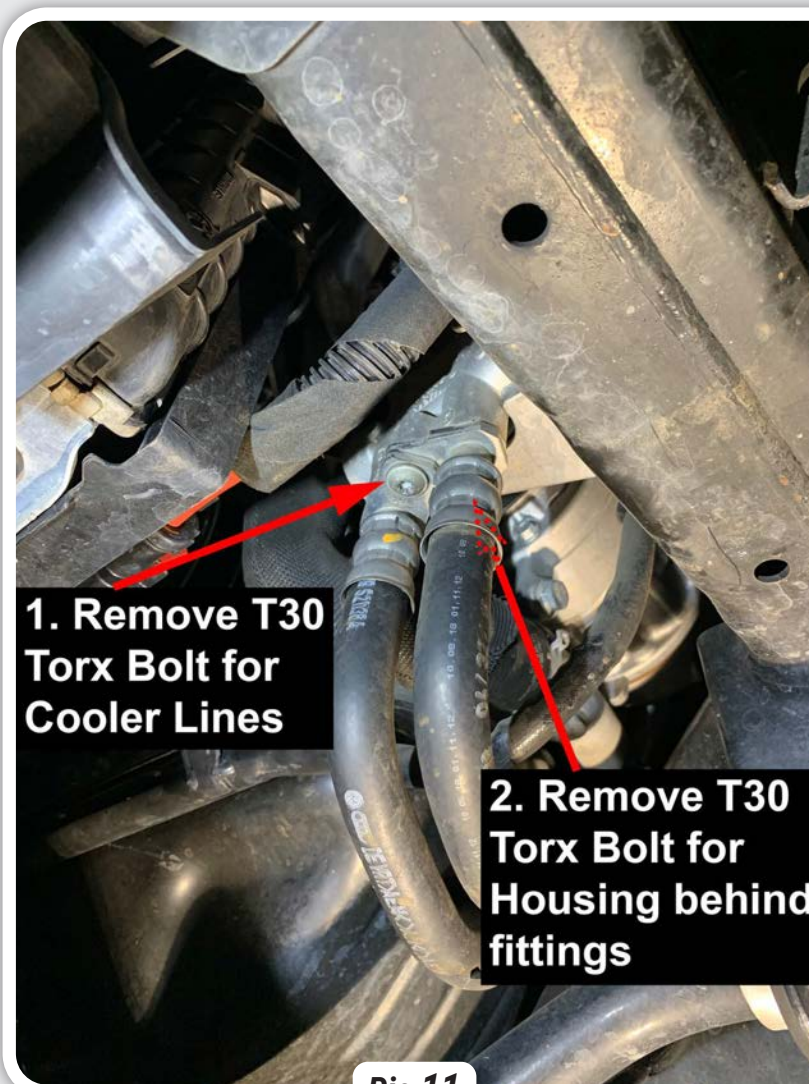
**Pic 11**

18. Remove the T30 torx bolt that secures the two lower cooler lines, then remove lower cooler lines. The line closest to the engine is removed first.
19. Locate the second T30 torx bolt under the thermostat housing and remove. This is the bolt that secures the thermostat housing to the chassis. **(Pic 11)**

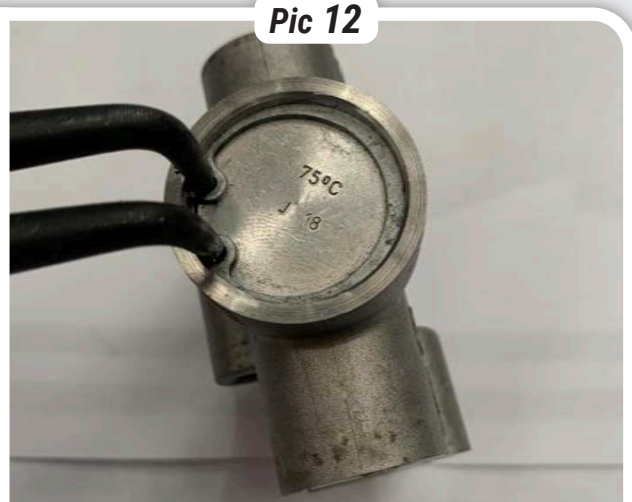
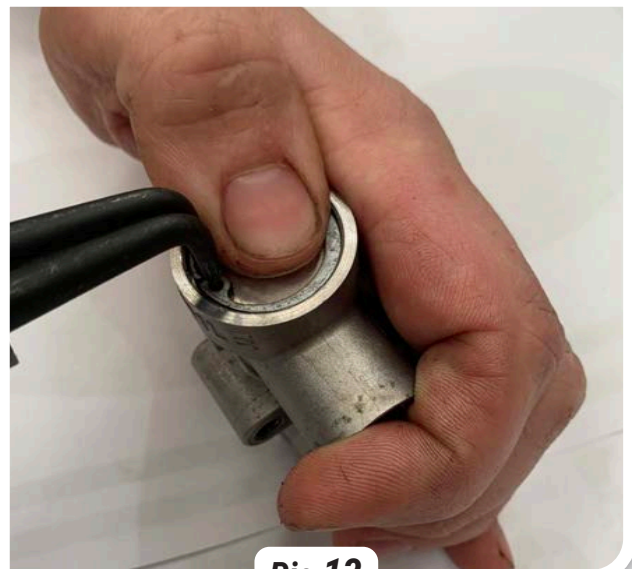
20. With the thermostat housing on the bench, using the circlip pliers and your fingers, apply pressure to the endcap enough to remove circlip. **(Pic 12)**
21. Slowly release the pressure on the endcap and allow it to come out. You may need to manipulate the endcap to get it to release. Keep your hand covering the endcap to prevent it from flying off due to the internal spring. **(Pic 13)**

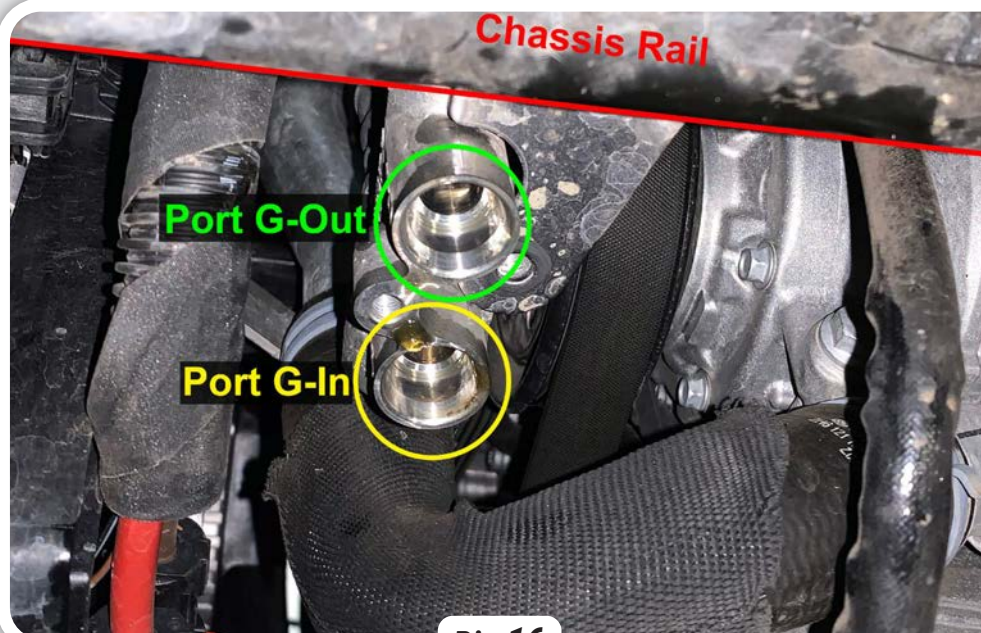
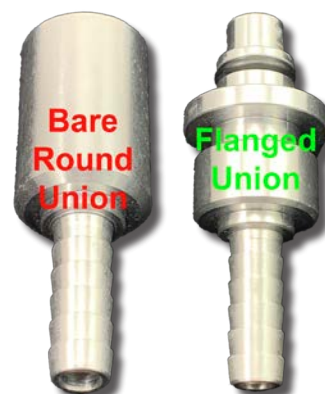
- 27.** For the next step, please take note of the names of the following parts so that it all makes sense. The changes being made are to only one port - G-Out. **(Pic 16 & 17)**

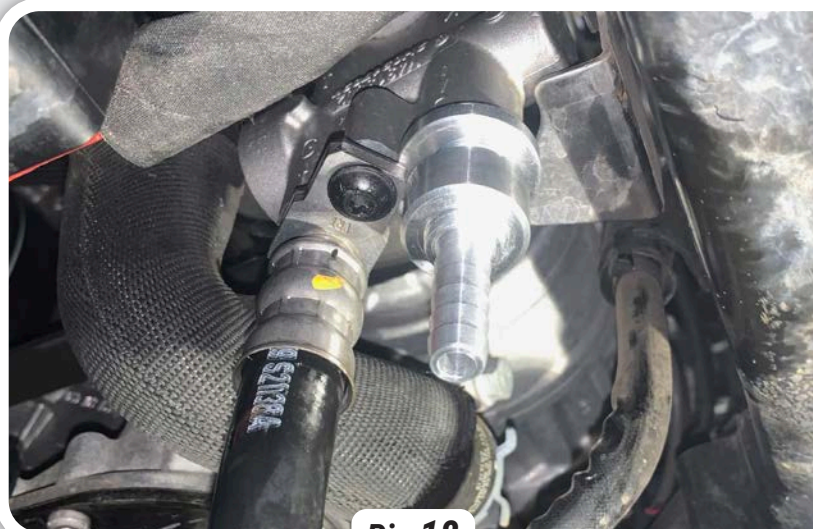
**Pic 18**

- 28.** First install the Flanged Union into the port labelled G-Out. Insert the factory original fitting into the port labelled G-In. The flange on the original fitting also secures the Flanged Union in place. Secure with supplied T30 torx bolt only. Do not use original bolt. **(Pic 18)**

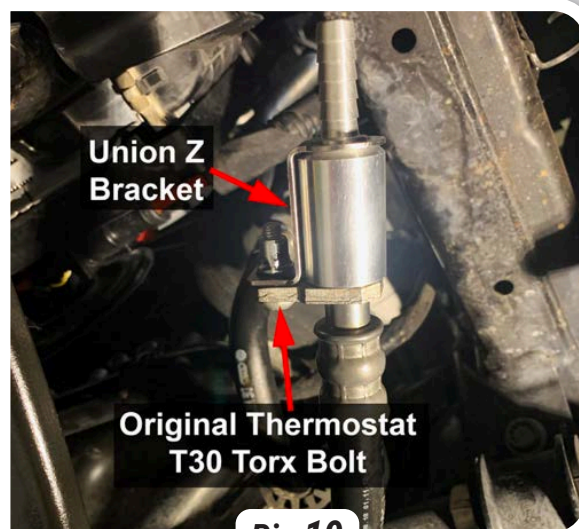
**Pic 19**

- 29.** Insert original cooler fitting from port G-Out into the Bare Round Union. Secure in place with supplied union Z bracket and original T30 torx bolt replaced in previous step. **(Pic 19)**

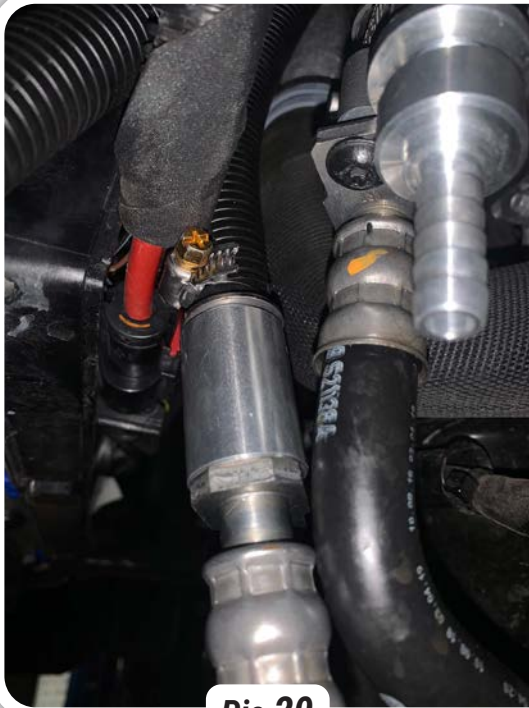
**Pic 20**

- 30.** Route cooler hose from new cooler down to custom unions. Cut one side of the looped cooler line for the Bare Round Union (the cooler lines are multi directional - it does not matter which way it flows). This union will sit beside the thermostat housing once complete. Secure with screw clamp. **(Pic 20)**

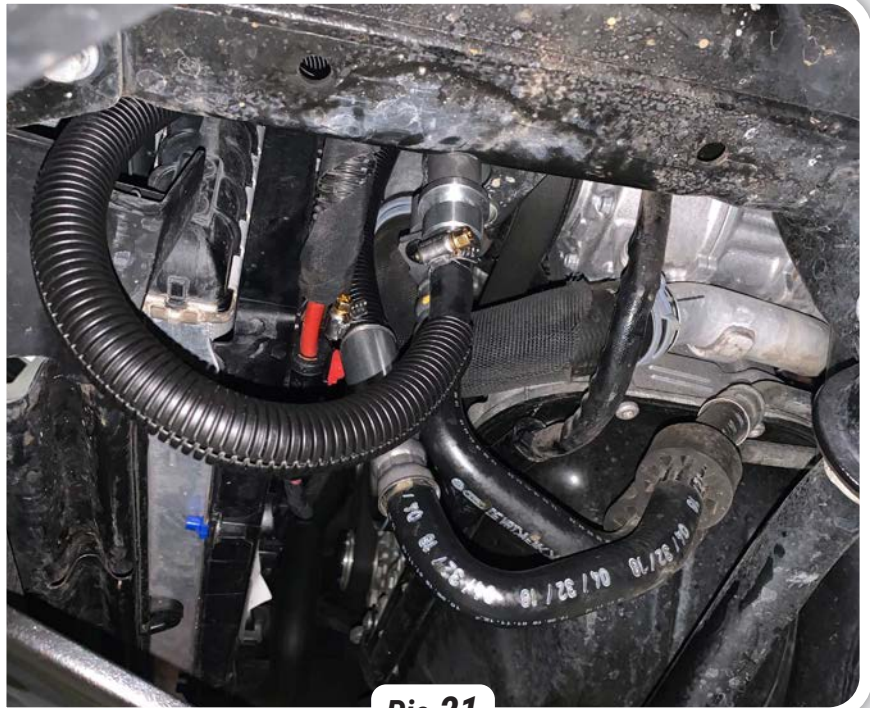
**Pic 21**

- 31.** Fit the looped hose to the Flanged Union in port G-Out and secure with supplied screw clamps. **(Pic 21)**
- 32.** Cable tie all cooler lines under the vehicle to prevent them coming in contact with hot or moving parts.
- 33.** In the engine bay, re-install the two upper cooler lines into the housing. The cooler line closest to the chassis must be inserted first. Re-install T30 torx bolt to secure lines.
- 34.** Cable tie all cooler lines in the engine bay to prevent them coming in contact with hot or moving parts.
- 35.** Re-install the air intake pipe removed in step 2 and secure. Re-install engine cover (if fitted).
- 36.** Before installing front grill, please re-check all fittings are tight and that there is no wiring touching the cooler.
