SK® 62TE

Fits: 62TE 2007-17

Corrects / Prevents / Reduces
TCC Slip/Shudder, Overheating, Drainback,
Delay or No Forward or Reverse, Coasting
6-5 UD Apply Clunk or 4-2 L/R Apply Clunk

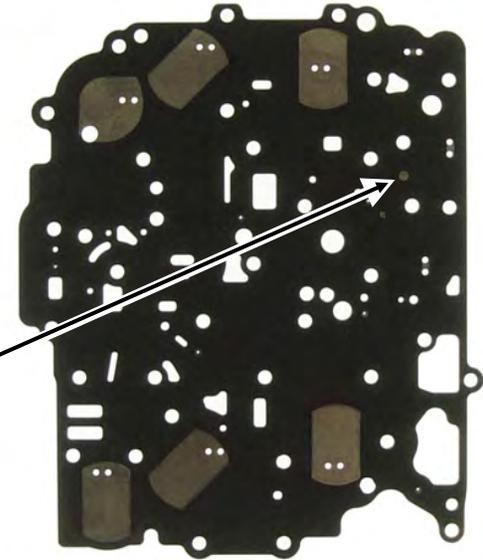
Install ball here only if plate has this hole.

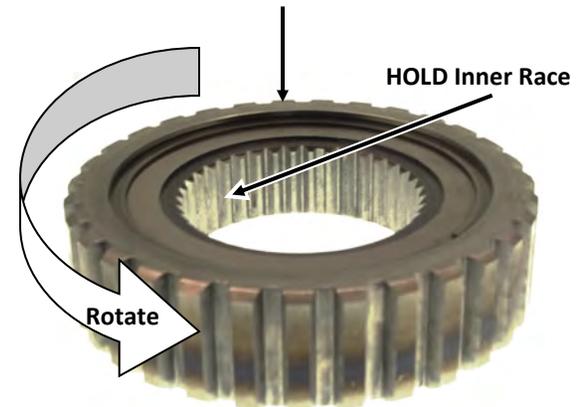
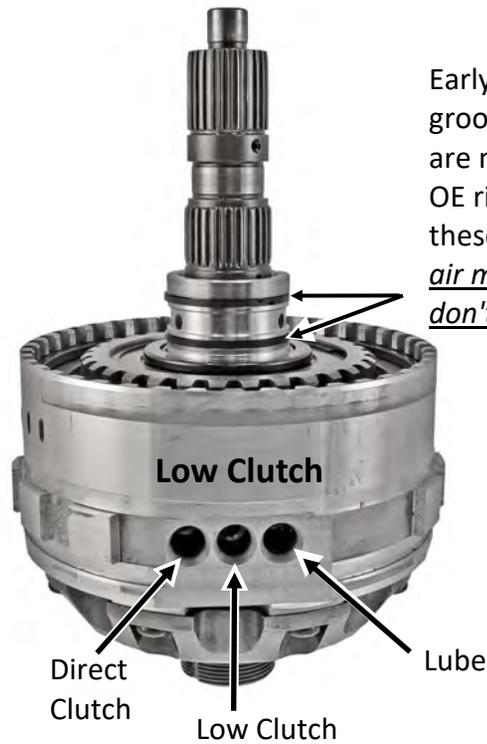
These 4 rings like to shrink dumping lube oil that can lower main line and accelerate ring land wear on the low clutch housing. 68018615AA

Early rotating rings usually destroy the ring grooves on low clutch housing. Later housings are notched for non rotating rings 05078800AB OE rings air check great and work excellent in these notched housings. 20-25 psi of regulated air must apply direct clutches on the bench, don't assemble unit until they do!

Updating the Low Clutch Housing to the latest Non-Rotating Ring type housing during overhaul is an great way to prevent rework due to ring groove damage. Even though it may not be damaged at time of overhaul, be warned, it does have a known high failure rate. Remember the customer pays for the parts now, you have to pay for them later.
