SK[®] 604 Shift Kit[®]

604/41TE & 606/42LE 1989-2013

Also fits 42RLE 2003-2011

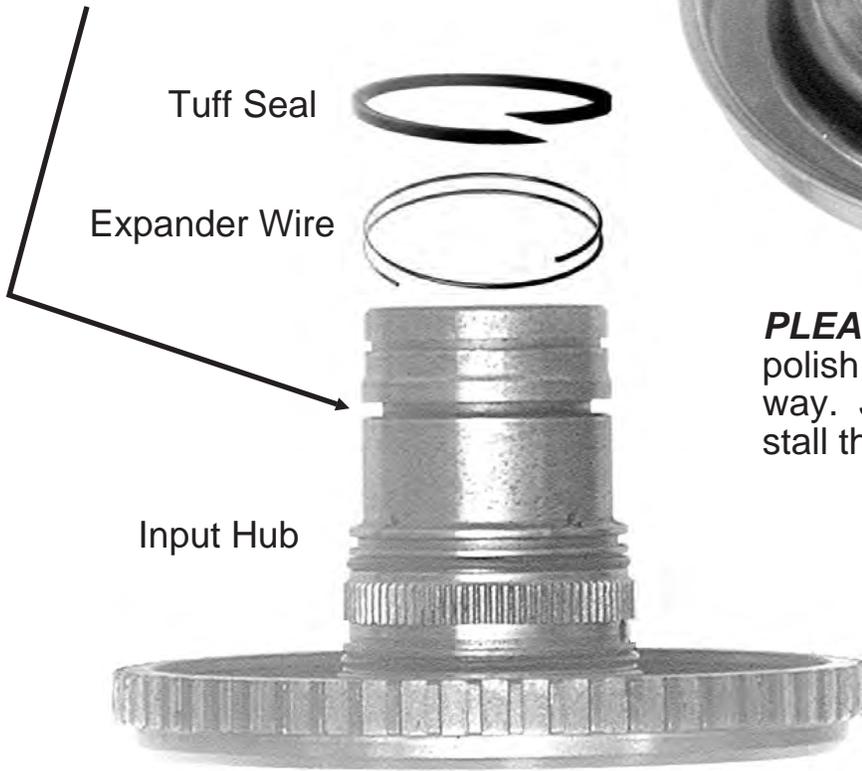
Underdrive Piston

Inspect piston here for wear and ridge.

COMPLAINT: Limp or Delayed Forward movement when cold, OR Limp after long freeway run: Code 36 & 39 or 53

Close inspection of underdrive piston bore will show wear and a ridge where the piston has rubbed against the seal groove in the input hub. This ridge nibbles the seal and the wear causes cold leak.

With a worn piston or a cut seal there will be a delay or no forward cold and sometimes limp on cold startup: until the seal warms and becomes more pliable.

During a long run in 4th the seal relaxes and fails to re-seal quickly causing limp, during a 4-3 coast downshift between 26 and 19mph.

The computer sees the delayed apply by watching the sensors and places trans in limp and sets code 36 along with 39 or 53.

PLEASE: Don't hone, sand, scrap, polish or try to fix the piston in any way. Just leave it like it is and install the seal. It'll work just fine.

A temporary solution is a new piston for \$27. A better fix is a quality self expanding seal that is pliable enough to seal into worn area and tough enough that the ridge won't cut it.

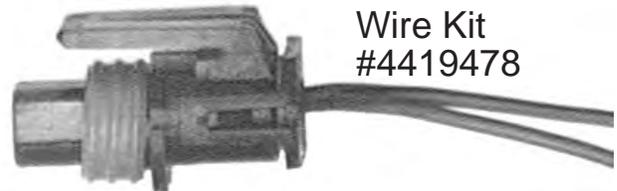
Wire Kit
#4419478

COMPLAINTS: LIMP with one or more of these codes: 39-51-52-53-54-56-57.

wiggled. Check turbine sensor the same way between pins 13 and 52 while someone wiggles the wires. If OHM meter wiggles on either test, resize the eyelets or replace wires with #4419478 and retest with wiggle.

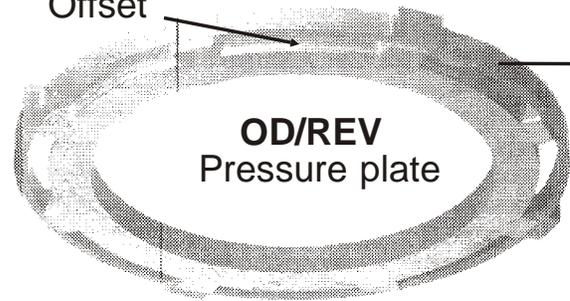
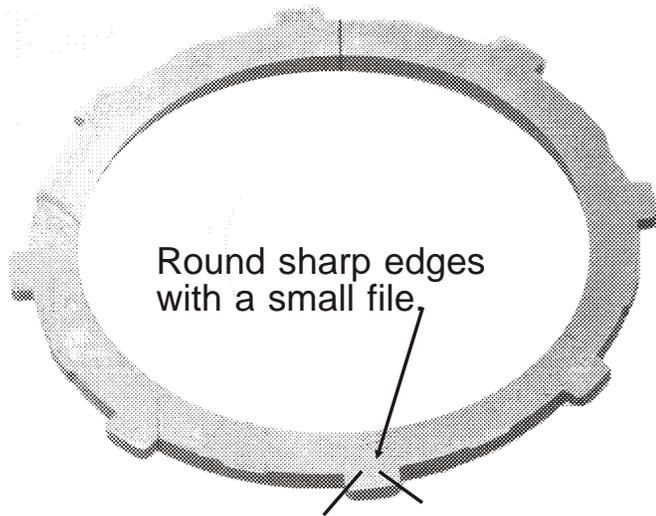
Offset

1st & 2nd type UD/OD pressure plates are flat & sharp across top and tooth.

To install four friction in early retainer:
Machine .045 to .055 of the offset side of the OD/Rev pressure plate.

File teeth edges. Just barely file edge of teeth so sharp edge won't cut snap ring.
