# SK<sup>®</sup> 700-G<sup>™</sup> TransGo<sup>®</sup> COMPLETE SYSTEM CORRECTION SysKo<sup>®</sup> Kit Shift Kit<sup>®</sup> The Genuine Fix: Even for the "Authorized Complaints" VALVE BODY, SERVO, ACCUM, GOVNR, PUMP PARTS/DATA

## PARTS AND INFO--FOR PREVENTION/CORRECTION OF THE FOLLOWING COMPLAINTS AND FAILURES:

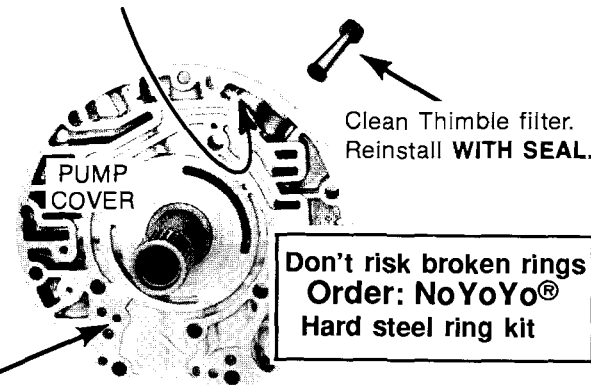
Move the drill motor — Leftward and Rightward to widen the top of the hole.

Use the same drill to check or enlarge the holes shown in the pump and pump cover.

**THE PROBLEM:** Clearances and wear allow more oil to enter seal area than the drainback hole can handle. Pressure builds under the seal causing the seal to blow out of the pump or leak.
