External Transmission Oil Cooler Kit

**Nissan Patrol Y62 with RE7
7 Speed Automatic Transmission**

WITH THE FOLLOWING ENGINES:
VK56 - 5.6L V8 Petrol - 2010 onwards

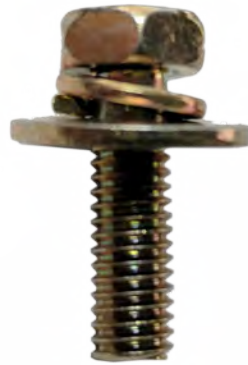
2 x 5/16" Coolers plus
1 x Custom Bracket

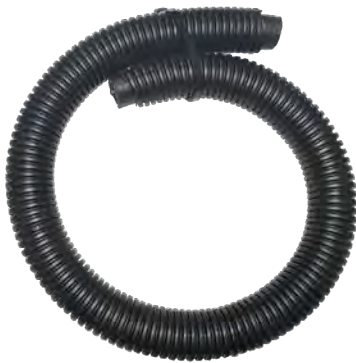
1.5m x 5/16" Cooler Line
Hose with Conduit

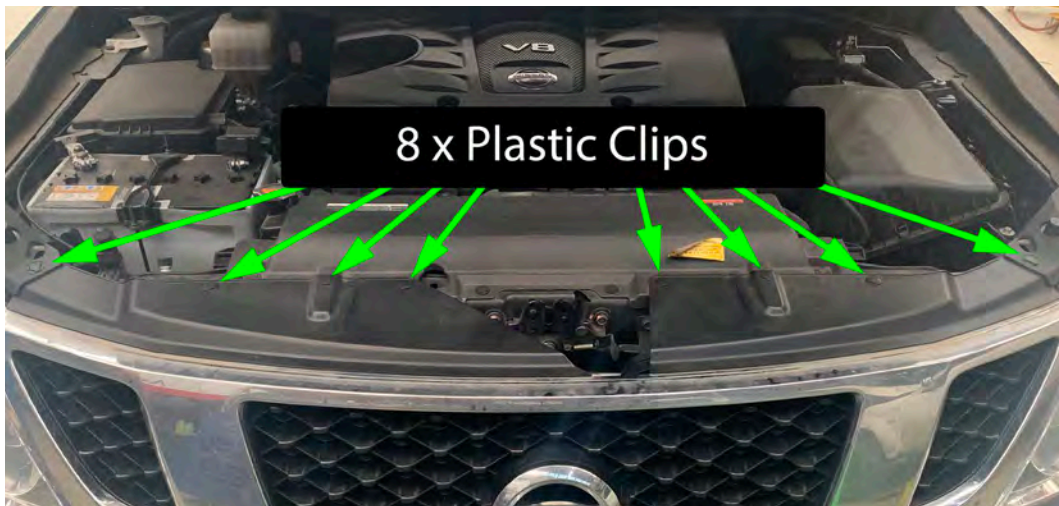
1. Remove any bash plates that are covering/protecting the radiator.
2. Remove the eight plastic clips holding the top shroud in place.

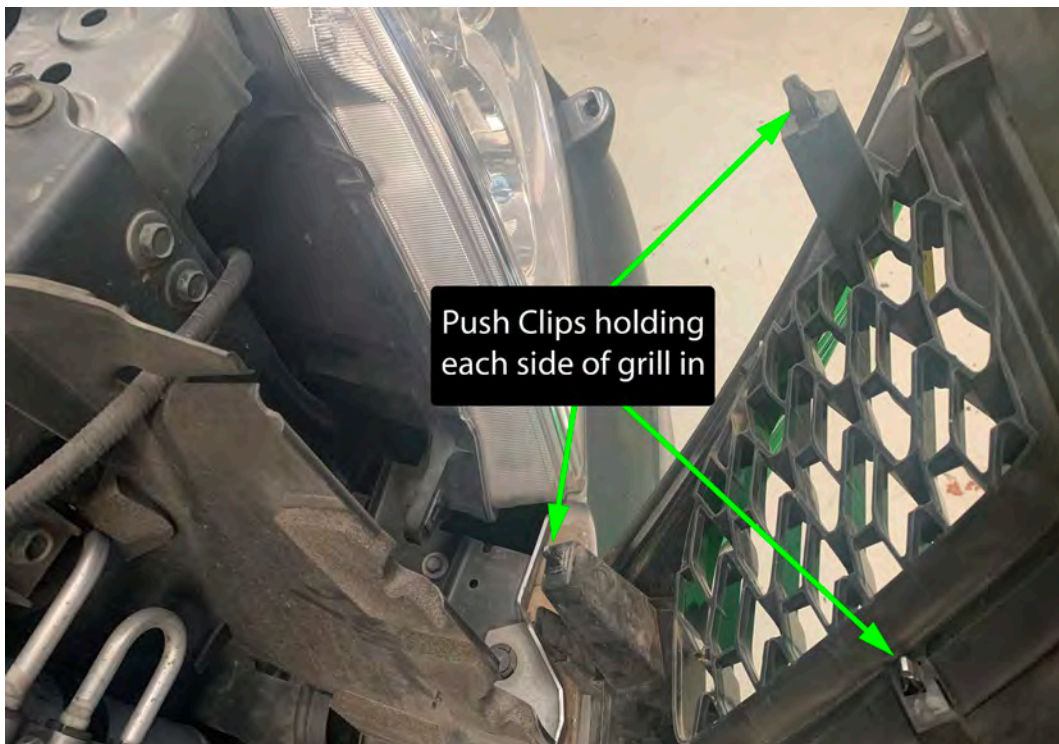
3. Pull forward gently on left and right sides of grill as they are held in with push clips.

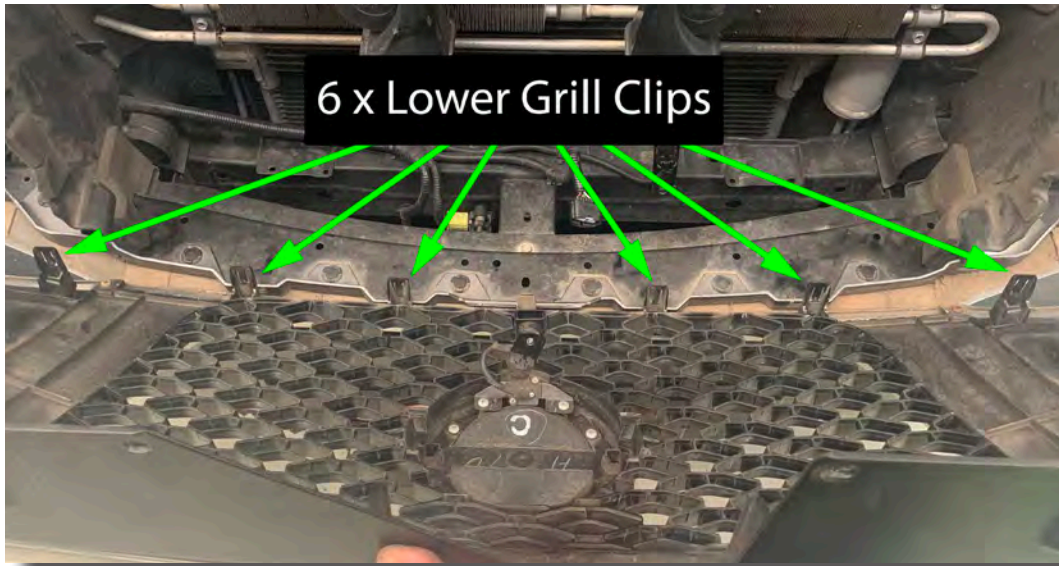
4. Unclip six flat grill clips at the bottom of the grill by lifting up on the clip

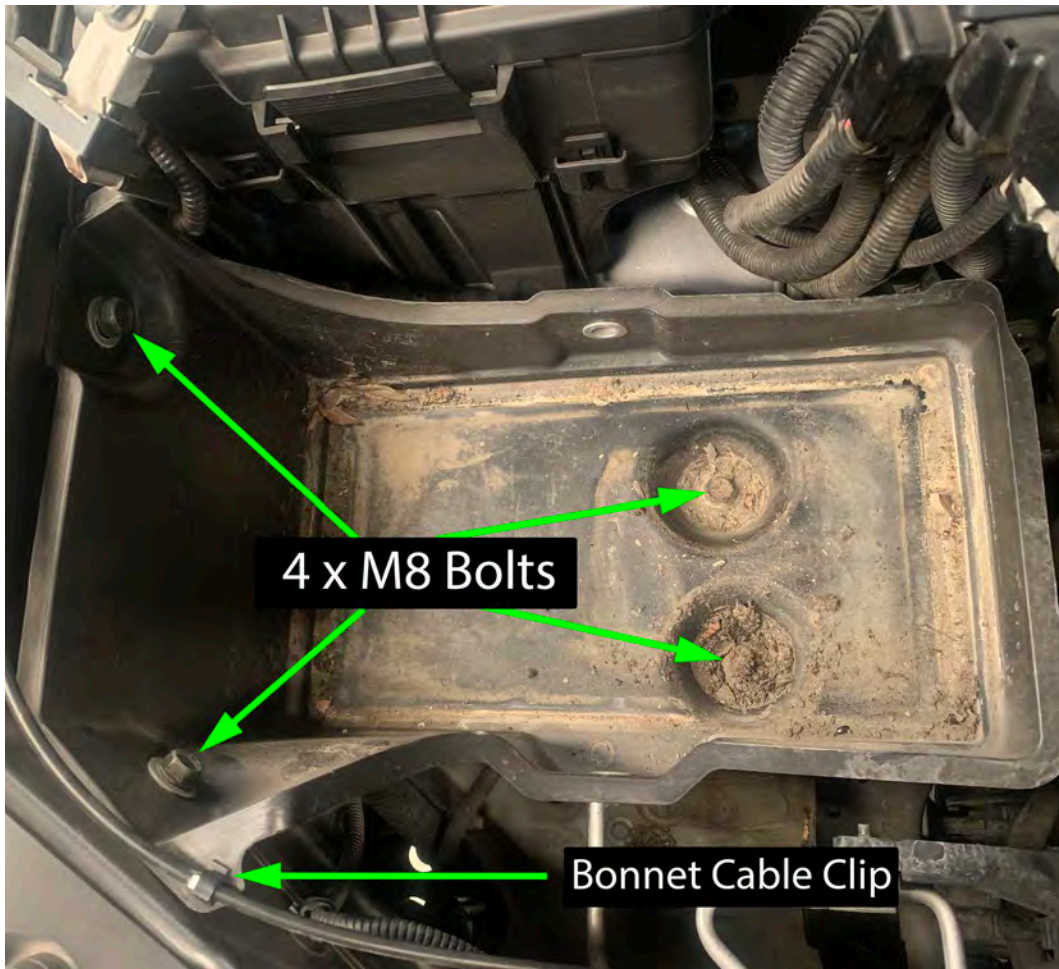
5. Remove battery and battery tray to allow easier access for removing OEM cooler hose and routing new cooler hose. Battery tray is held in by four (4) M8 Bolts and the bonnet cable clip.

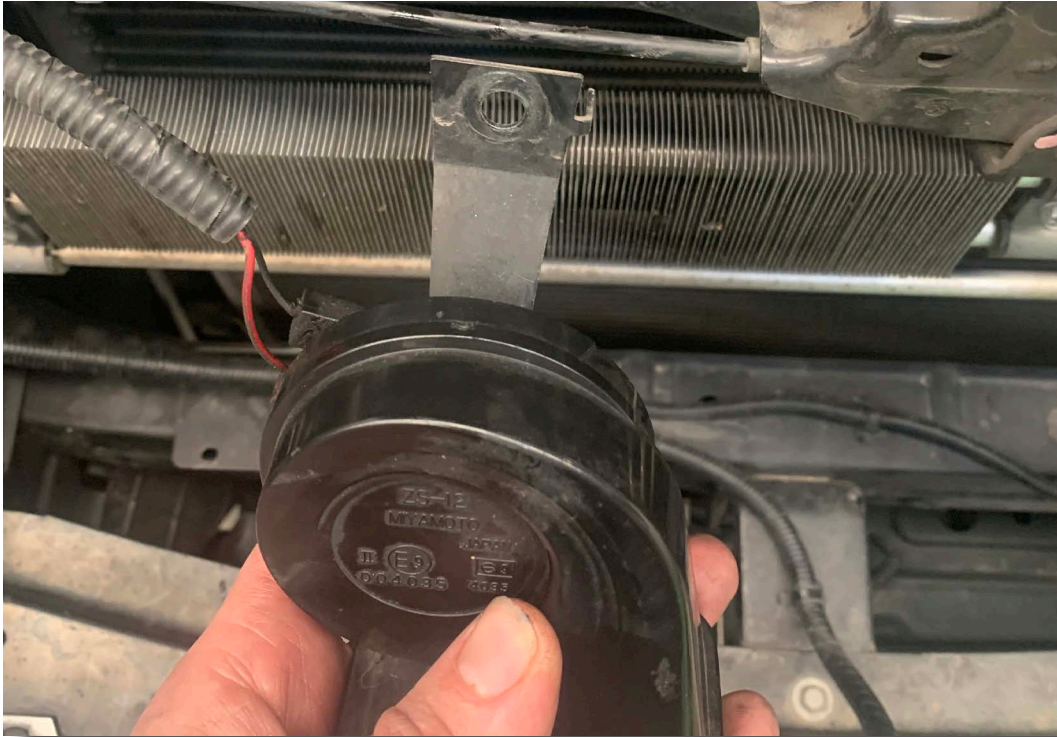
6. Remove the drivers side horn but leave wiring connected.

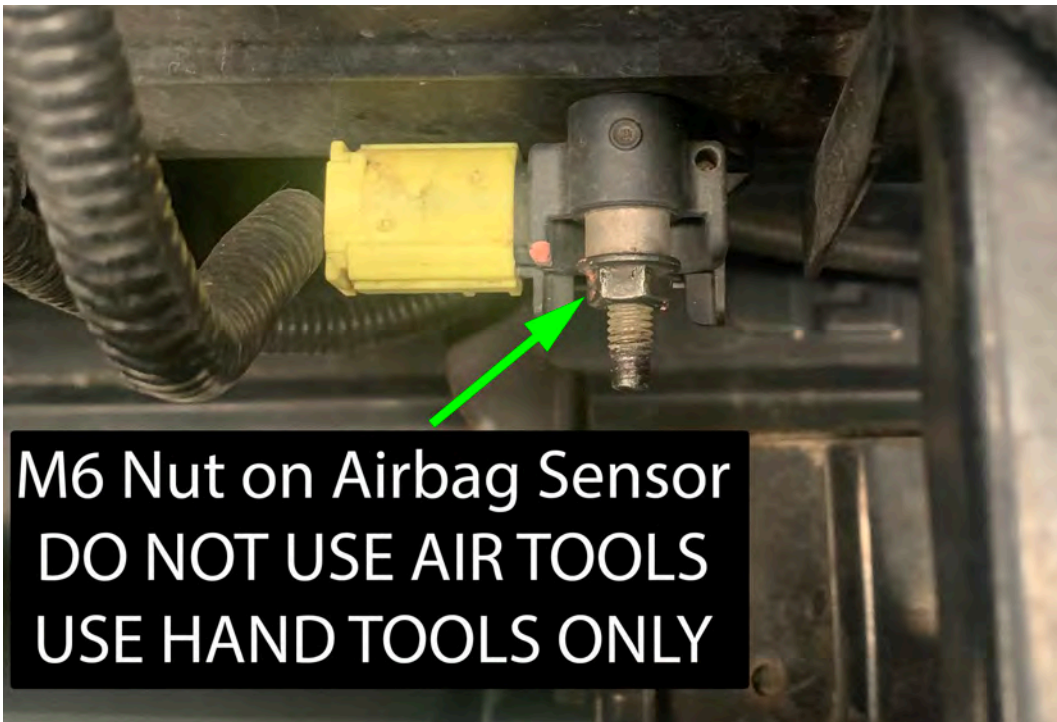
7. Remove the nut off the stud that is mounting the airbag sensor

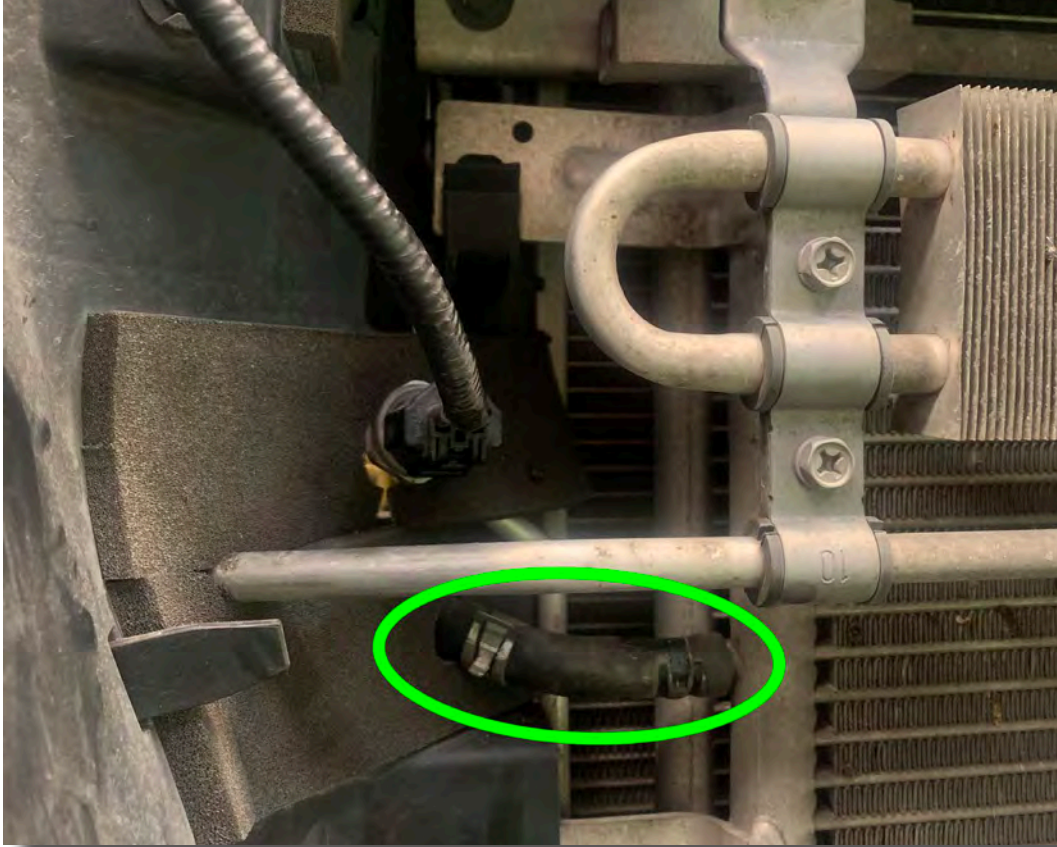
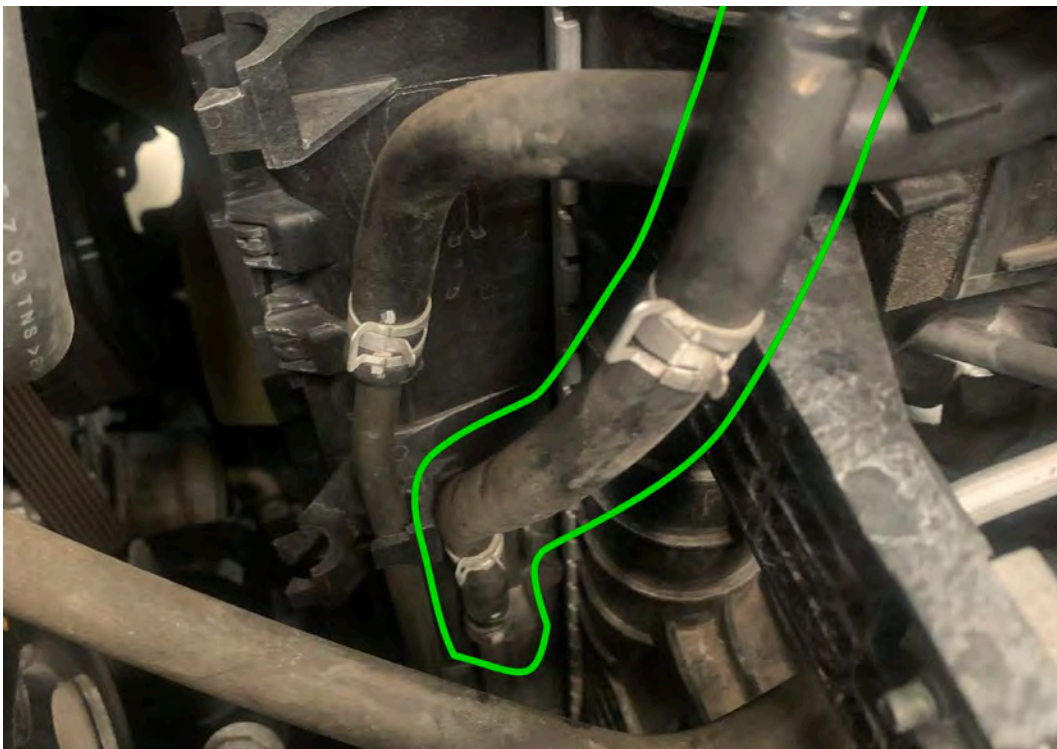
9. Remove clamps off the lower hose of the original cooler. Trace through radiator support to the other end of the rubber line. Remove clamp and then remove the OEM cooler hose.

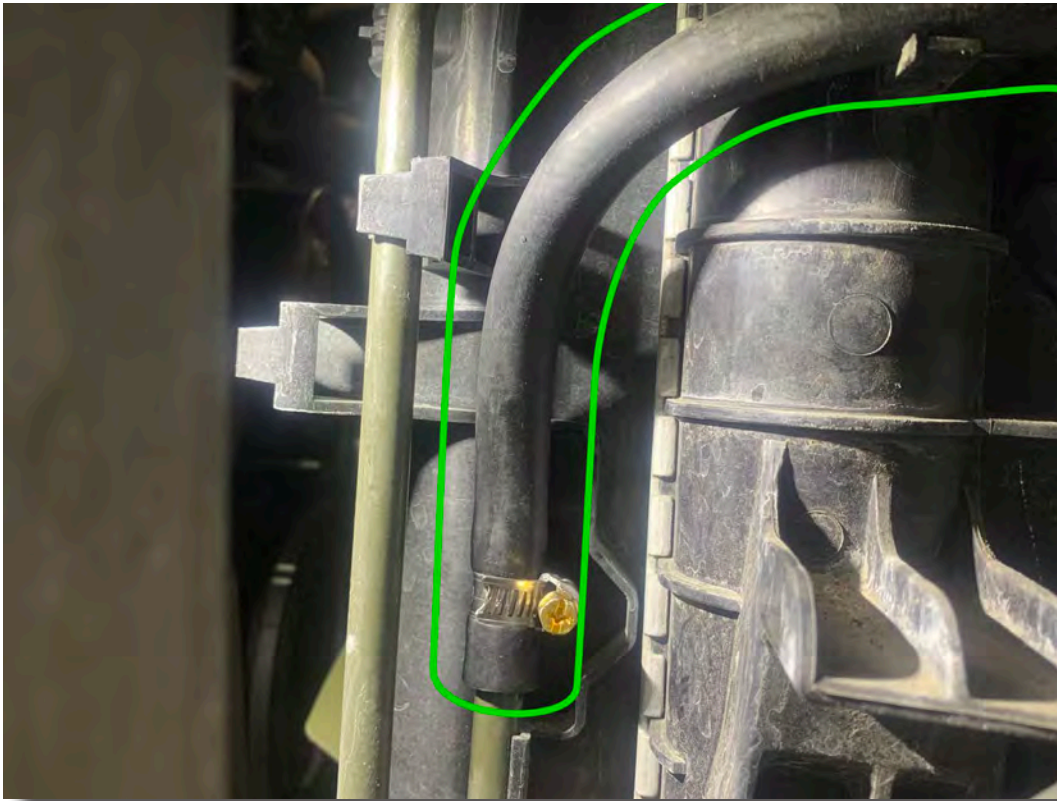
10. Fit new 8mm hose supplied in kit to the OEM in/outlets from removed OEM Hose. (Do not cut new hose into 2 separate lengths yet)

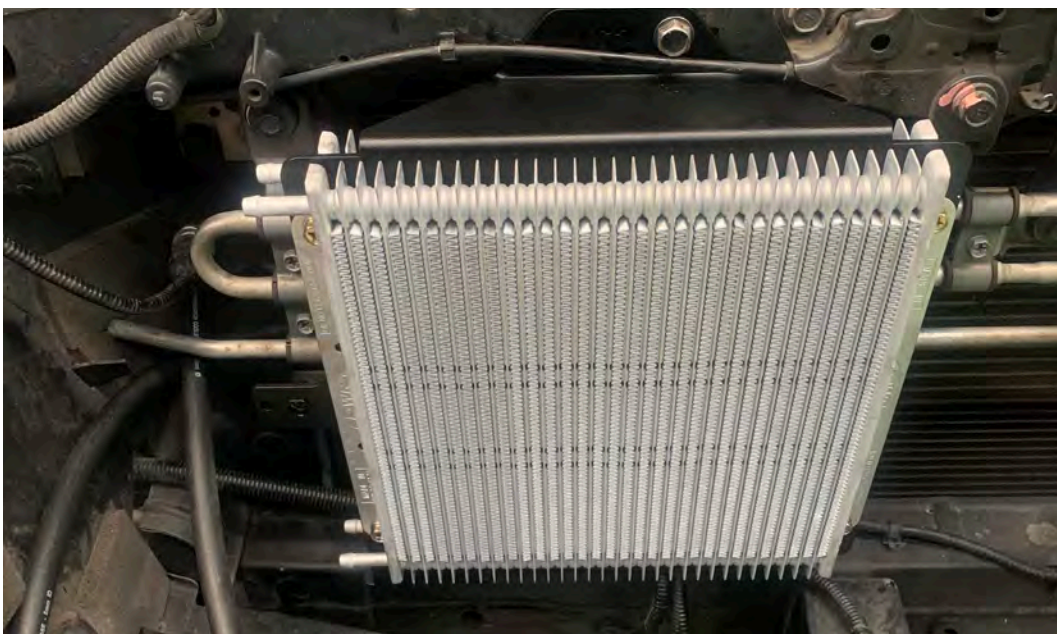
11. Fit the Dual Cooler bracket (with barbs facing the drivers side of the vehicle) to the original horn mounting hole, airbag sensor stud and to the flat section of the radiator support. The radiator support uses a M6x20 SEMS bolt fed from underneath up into the bracket.

- Remove lower hose of the original cooler
- Fit new 8mm hose supplied in kit. (Do not cut into 2 lengths yet)
- With hose in/outlets facing the drivers side of the vehicle, mount the cooler to the original horn mounting hole (OEM Bolt), Airbag Sensor stud (OEM Nut), and the flat section of the lower radiator support (supplied M6x20 SEMS bolt).

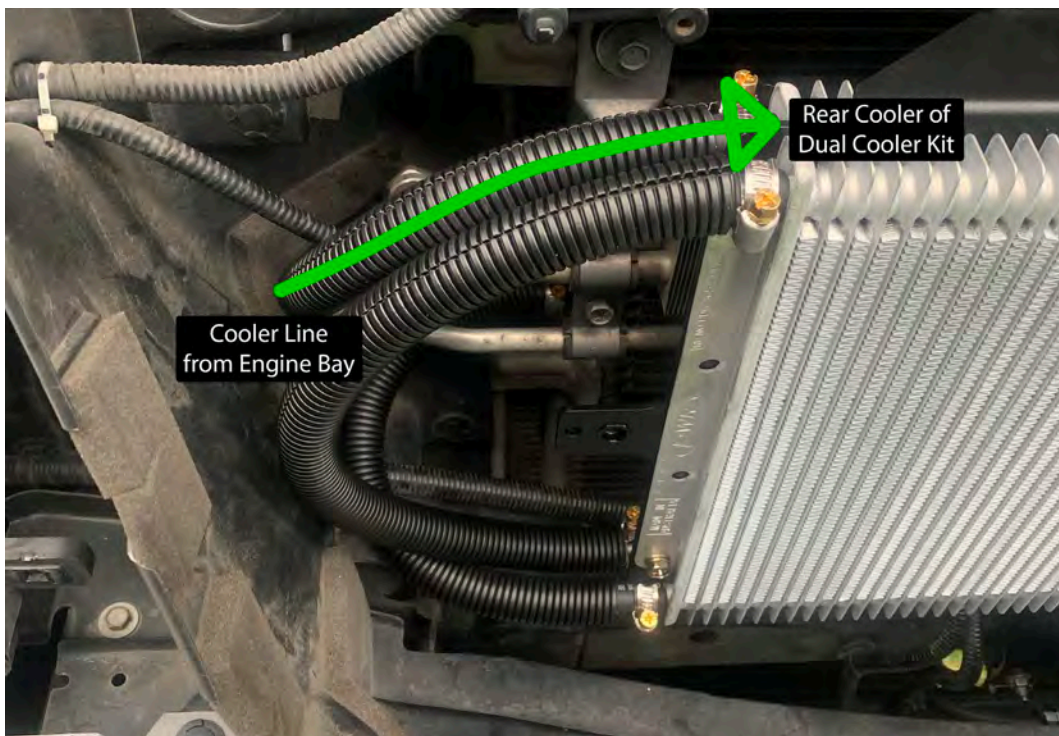
12. Fit hose that is coming from the pipe mounted on the radiator to the top of the rear cooler. Cut hose to length and use supplied new hose clamp

- Fit hose that is coming from the pipe mounted on the radiator to the top of the rear cooler. Cut hose to length and use new supplied clamp
- Fit hose that is on the OEM transmission cooler to the bottom of the front cooler. Cut hose to length and use new supplied clamp.

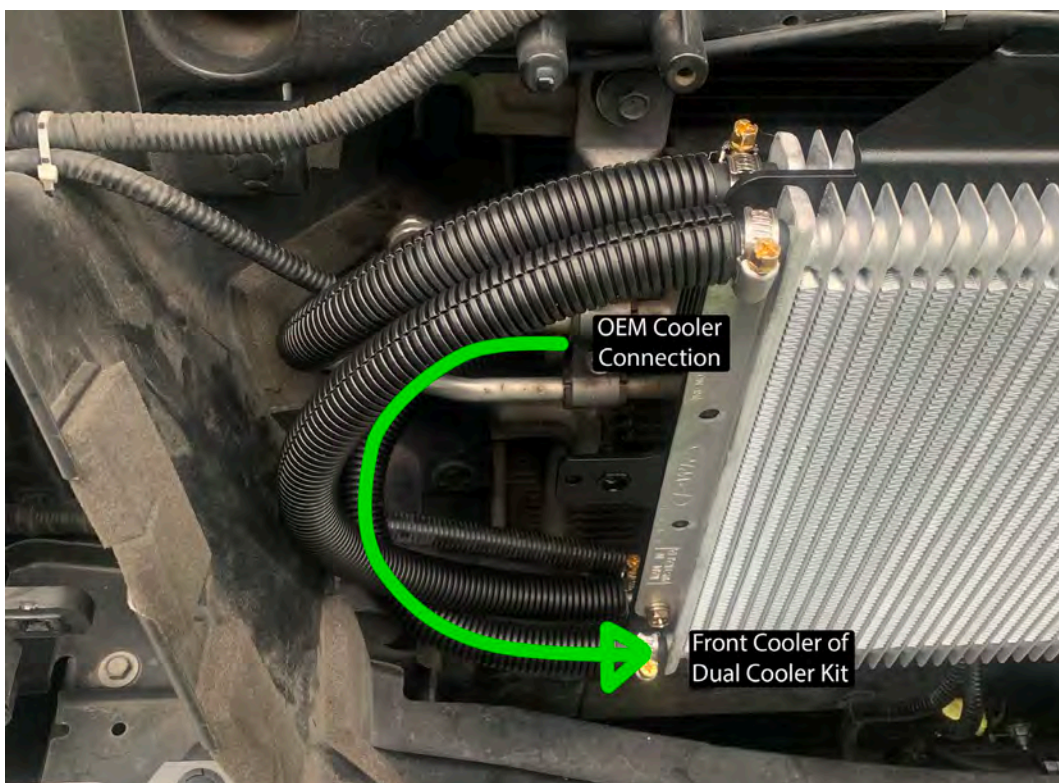
13. Fit hose that is on the OEM transmission cooler to the bottom of the front cooler. Cut hose to length and use supplied new hose clamp.

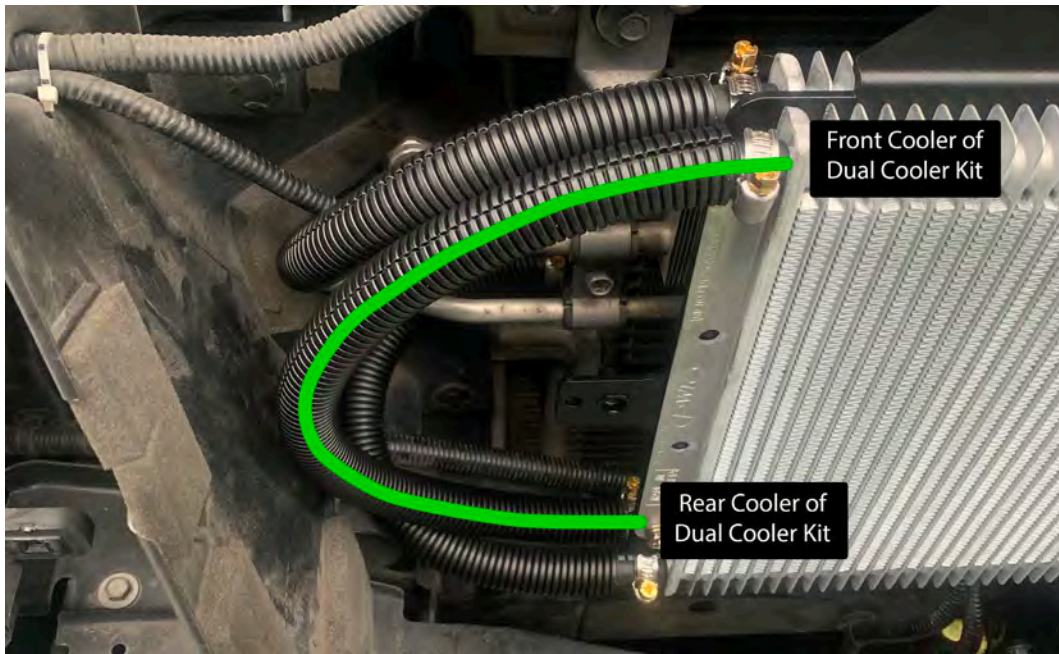
14. Fit supplied 500mm Dual Cooler link hose to join the front cooler to the rear cooler.

- Fit supplied 500mm Dual Cooler Connection hose to the remaining in/outlets on the front cooler and the rear cooler.
- Before refitting horn, rotate bracket 180° and re-tighten. (Horn outlet needs to be facing down so it doesn't collect water).

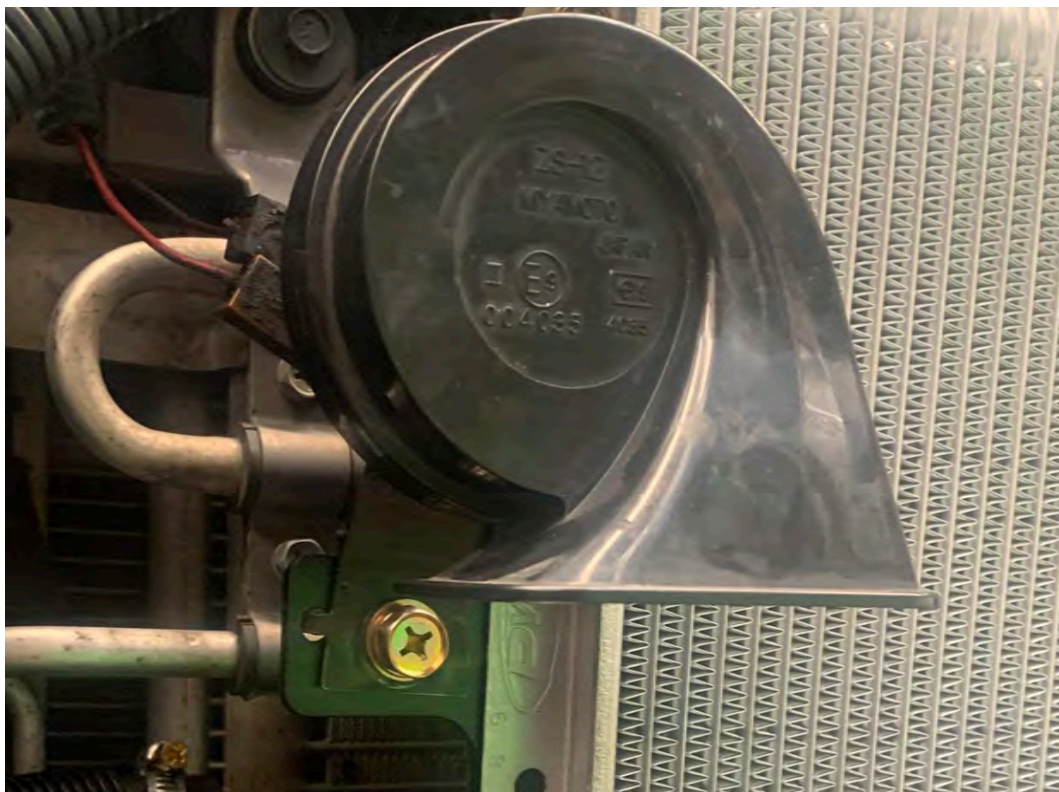
15. Before refitting horn, loosen 10mm nut on the horn and rotate bracket 180° and re-tighten. (Horn outlet needs to be facing down to prevent the chance of water ingress). Then mount horn to the new cooler bracket with supplied M8x20 SEMS bolt. The locator tab should match hole in bracket.

- Mount horn to the new cooler bracket with supplied M8x20 SEMS bolt.
- Refit battery tray and battery.
- Check transmission oil level
- Check for leaks
- Refit grill.

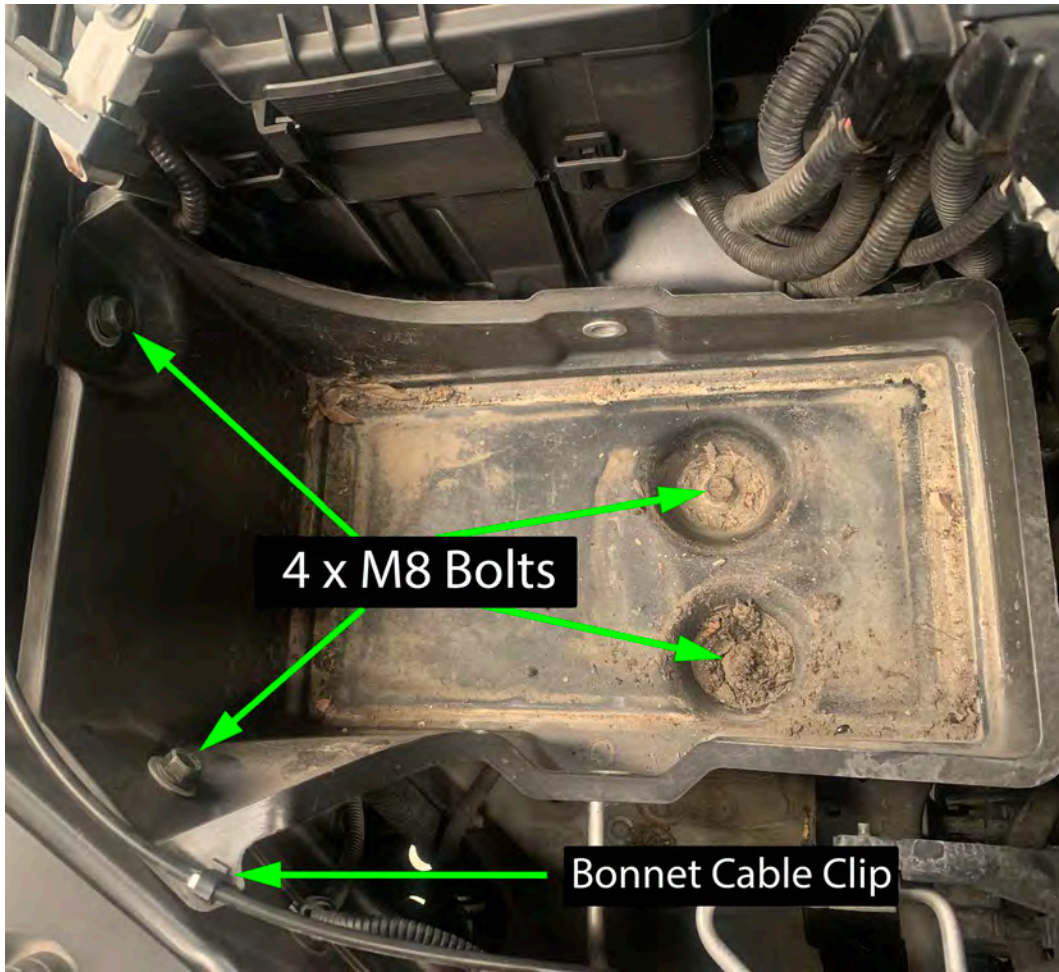
16. Refit battery tray and battery.

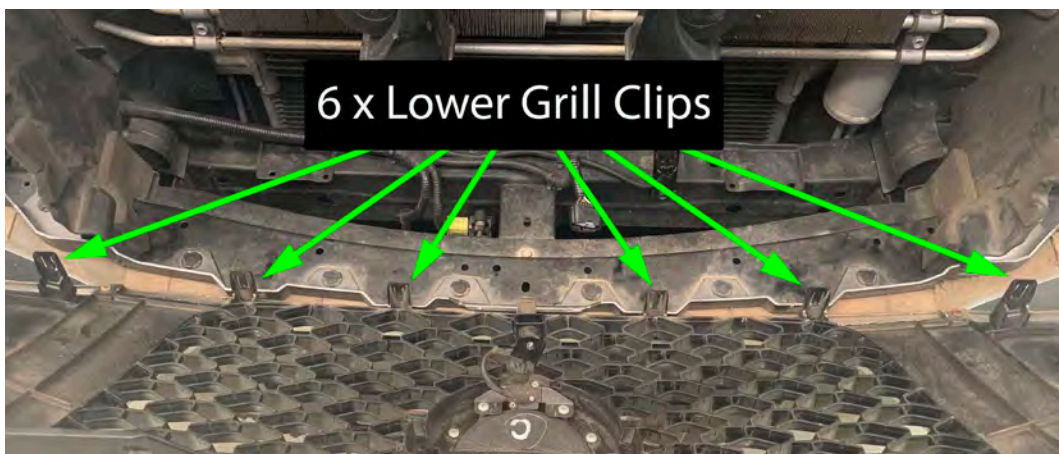
17. Start engine and leave transmission in Park position.
18. Verify there are no leaks coming from any of the connections. If no leaks detected, refit front grill and top radiator shroud by pushing the lower grill clips in first.

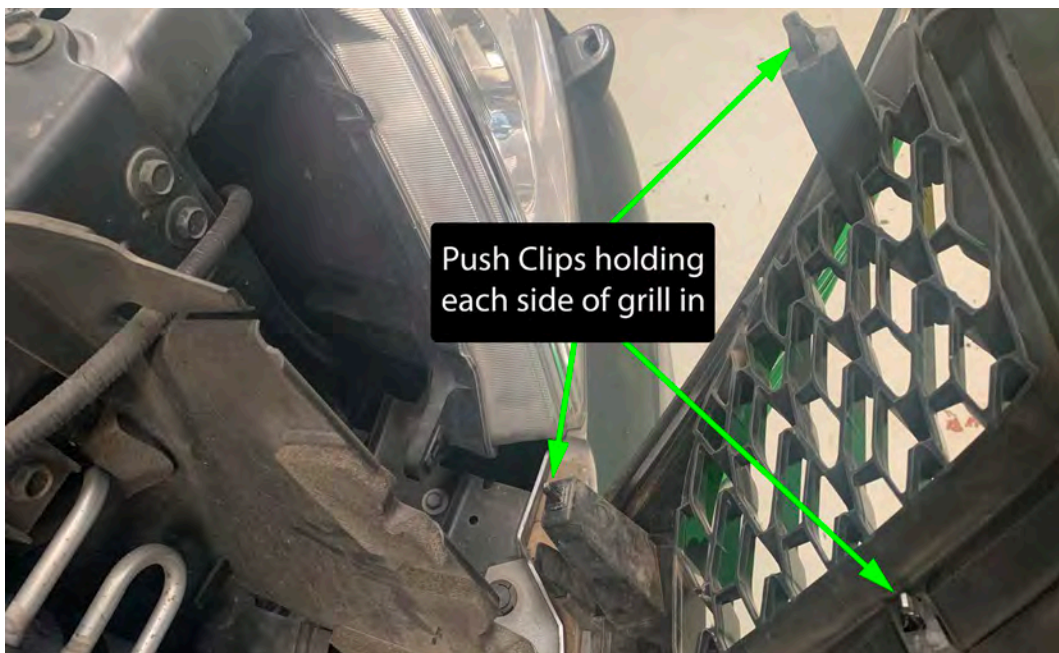
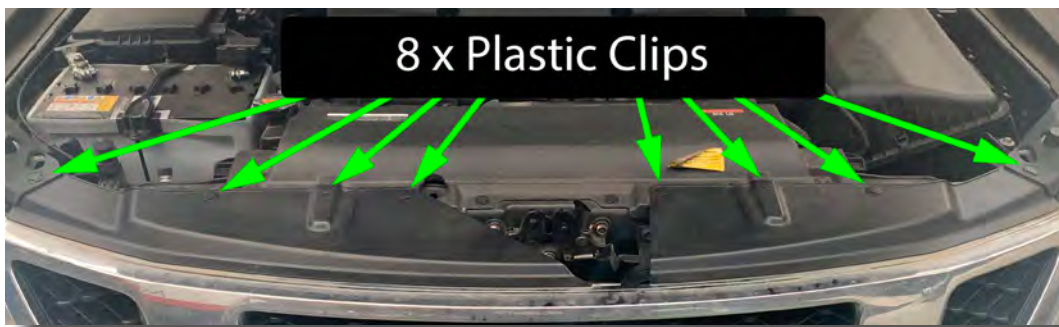
19. Then push fit the remaining clips on the outer edges of the grill and refit the 8 (eight) x grill clips holding the upper cover to the vehicle

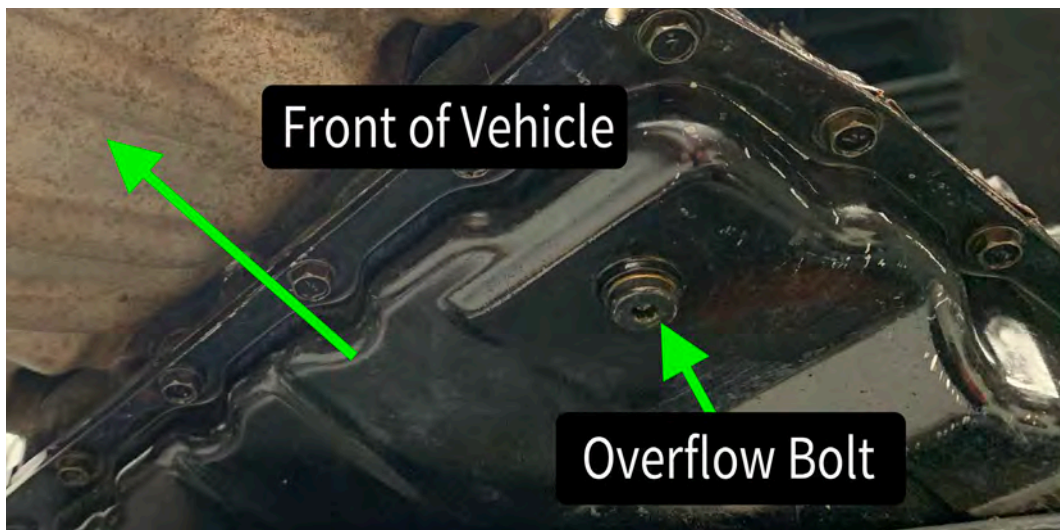
21. Once the engine has been running for at least 1 minute, move a drain tin into place under the overflow outlet and then remove the 5mm hex bolt.

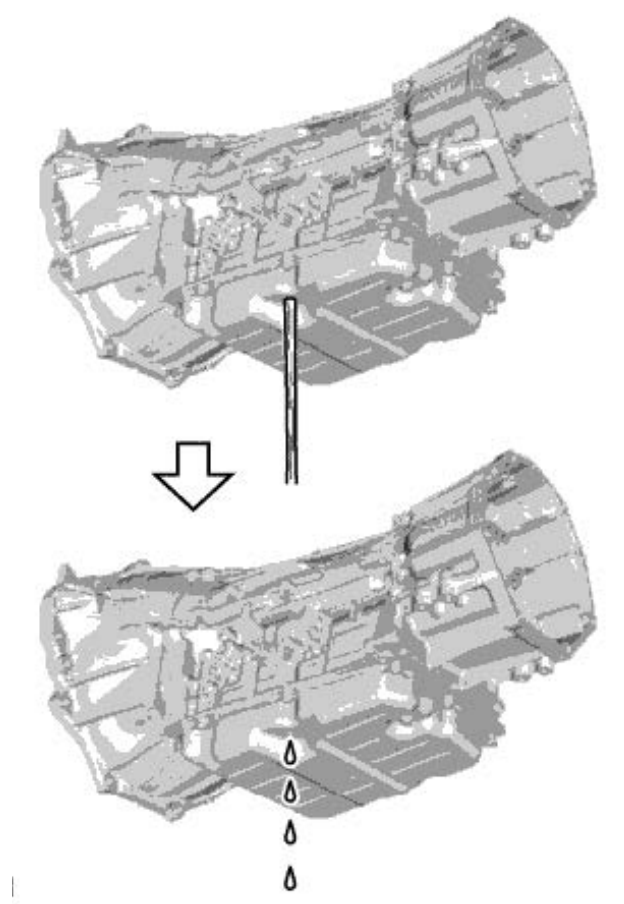
22. If the transmission fluid starts to flow out of the overflow tube in a light but steady stream (as indicated in the image below), then there is sufficient fluid inside the transmission. Wait until it slows to a dribble and re-install the overflow bolt. You can now skip to Step 26.

Image is not of the Nissan RE7 transmission. The image is to illustrate the flow of transmission fluid.

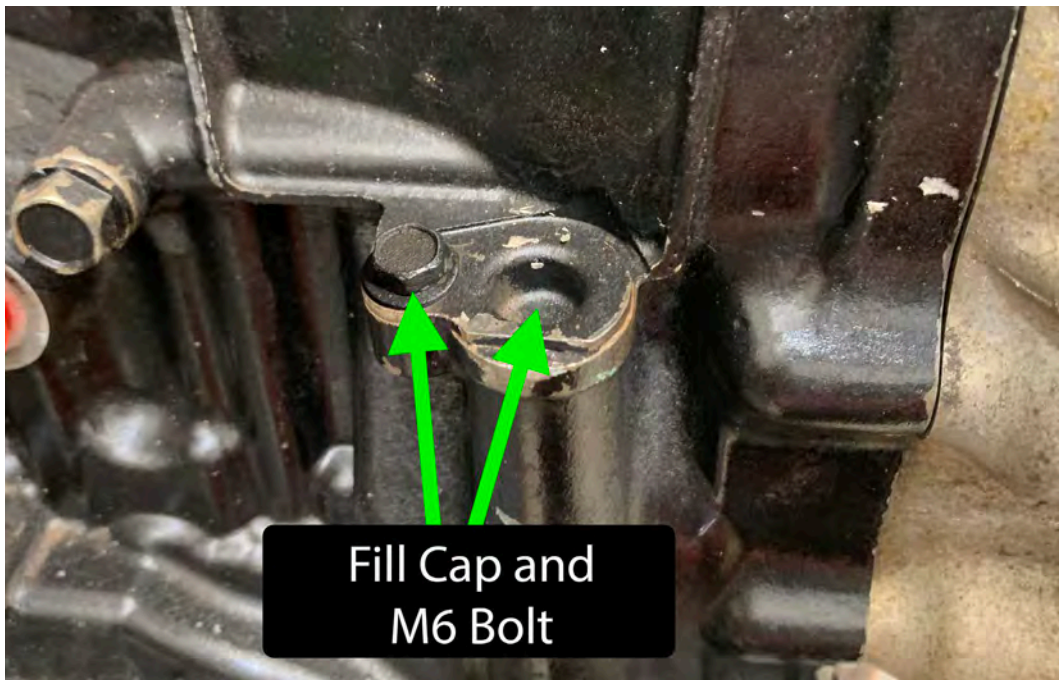
23. If there is no fluid flowing/dribbling from the overflow OR there was a small amount of fluid to start with but then stops, this indicates you need to add transmission fluid.
24. To add fluid, remove the M6 bolt holding a cap over the fill hole just above the front of the pan on the drivers side. Add fluid until there is a light but steady dribble out of the overflow tube. If you add too much and you get a stream of fluid, wait until it slows to a dribble.

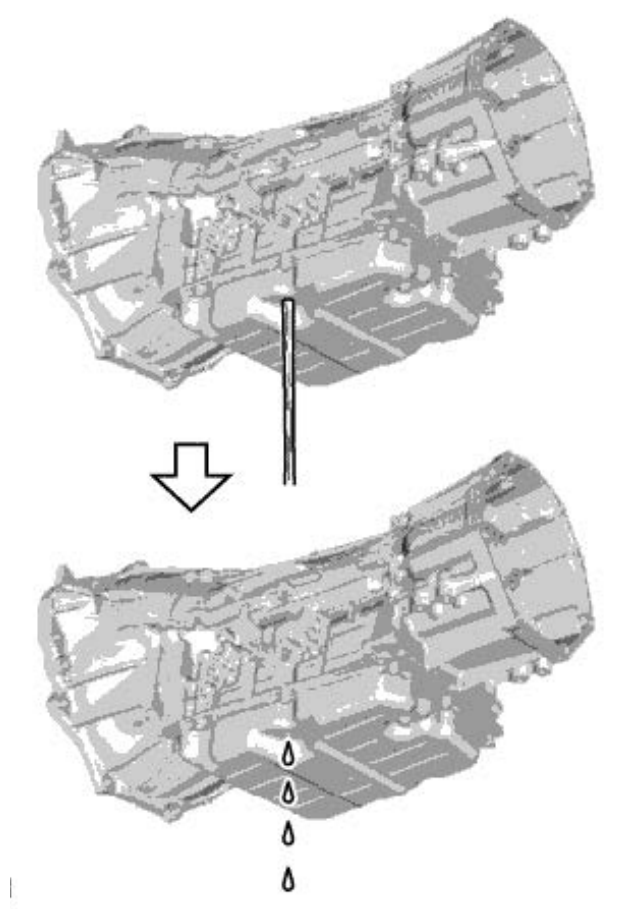
28. If there is no fluid flowing/dribbling from the overflow OR there was a small amount of fluid to start with but then stops, you have most likely cleared some air pockets and will need to add more transmission fluid. Return to Step 24.
29. If the transmission fluid starts to flow out of the overflow tube in a light but steady stream (as indicated in the image below), then there is sufficient fluid inside the transmission. Wait until it slows to a dribble and re-install the overflow bolt. Re-install the fill cap and bolt if these were removed during this process.
