External Transmission Oil Cooler Kit Suitable for:

Volkswagen Amarok 2H with 8 Speed ZF8HP26 Automatic Transmission

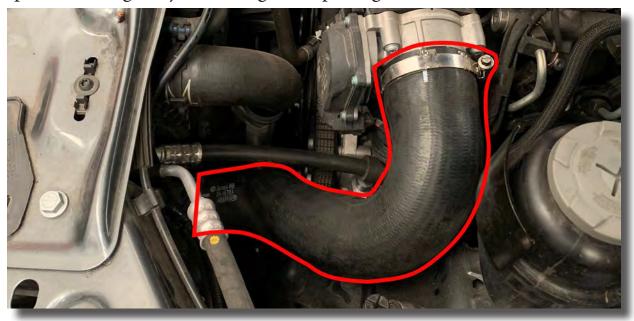
- 1. Open bonnet
- Remove engine cover (if fitted) and then locate and remove the air intake 2. pipe between intercooler and throttle body. Cover intake openings to prevent foreign objects falling into openings.

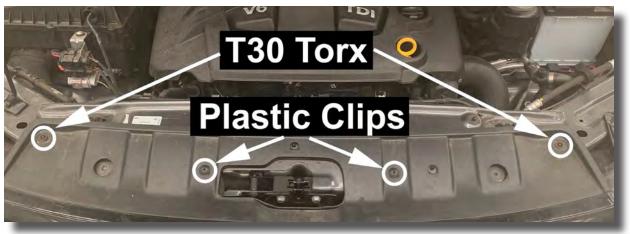
Remove the two (2) T30 torx screws from the outer edge of the radiator 3. shroud and the two (2) plastic clips towards the inside edge.

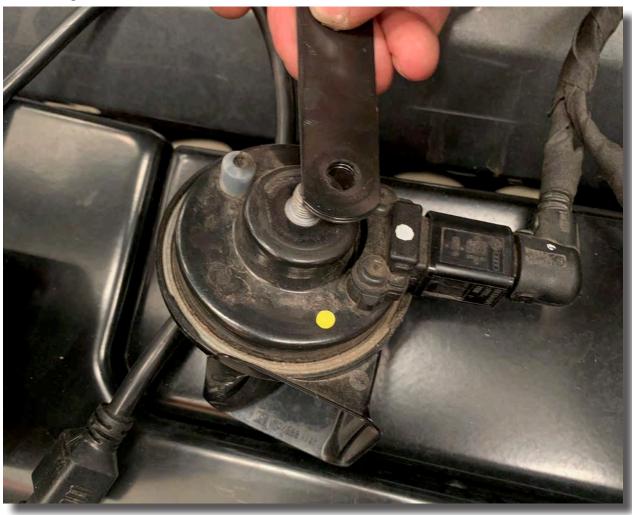
- 4. For vehicles with factory bumper, unclip the twelve (12) clips holding the bottom of the grill to the bumper.
- 5. For vehicles fitted with aftermarket bullbars, there may be additional mounting bolts that will need to be removed to free the grill. Please refer to the bullbar manufacturers installation instructions for further details.
- 6. Remove horns from mounting brackets by removing the nuts and washers holding each horn. Save hardware for later use.

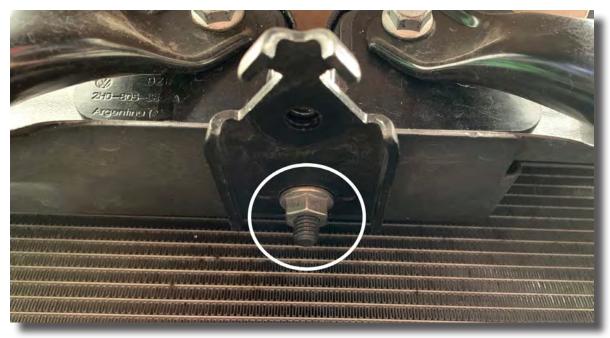
7. Remove the 13mm nut holding the horn bracket assembly from underneath the horn bracket.

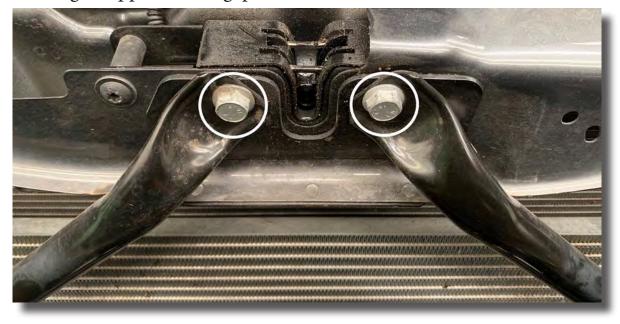
8. Loosen the two (2) bonnet catch bolts holding the top of the diagonal brace bars to give approx 6mm gap.

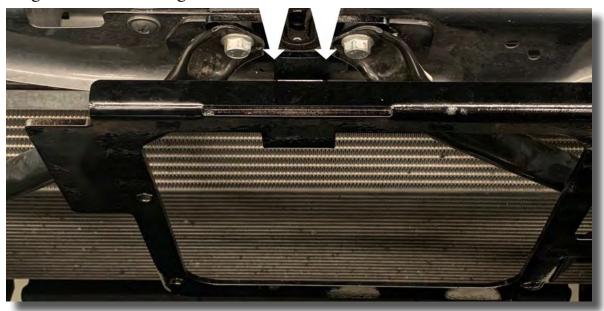
Lower the cooler bracket into place and slide the two (2) upper mounting 10. wings behind the diagonal brace bars.

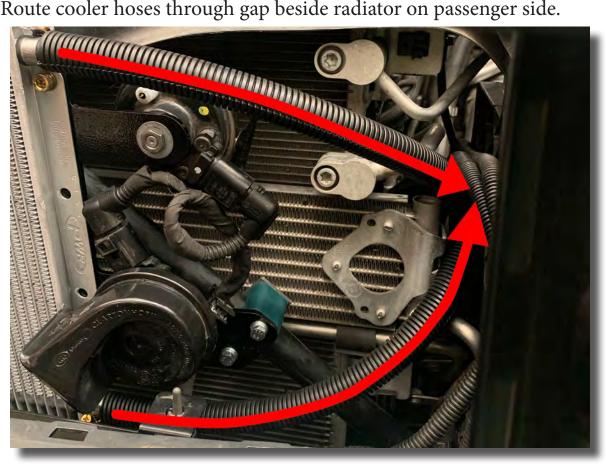
Route cooler hoses through gap beside radiator on passenger side. 11.

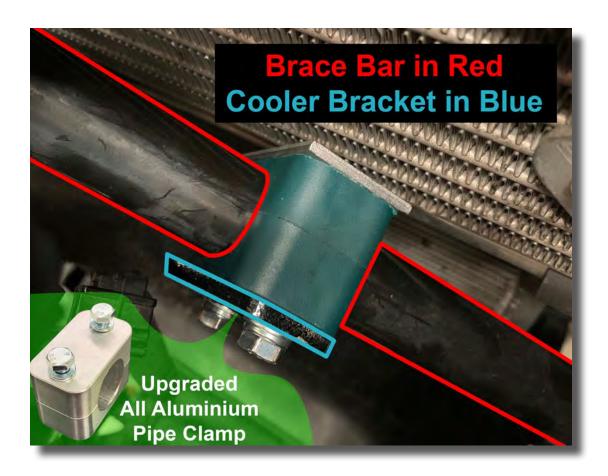
12. **We have upgraded the pipe clamp to an all aluminium two piece clamp to aid fitting in the tight space behind the brace bar. The second half of the clamp is threaded which means we no longer require the seperate plate.**

Remove the two (2) bolts and washers from the upgraded pipe clamp. Place the non threaded clamp half between the cooler bracket and the brace bar and feed the two (2) bolts and washers through to hold in place.

Place the pipe clamp half with the threaded holes behind the brace bar and screw the two (2) bolts into the threaded half.

Tighten both bolts to secure.

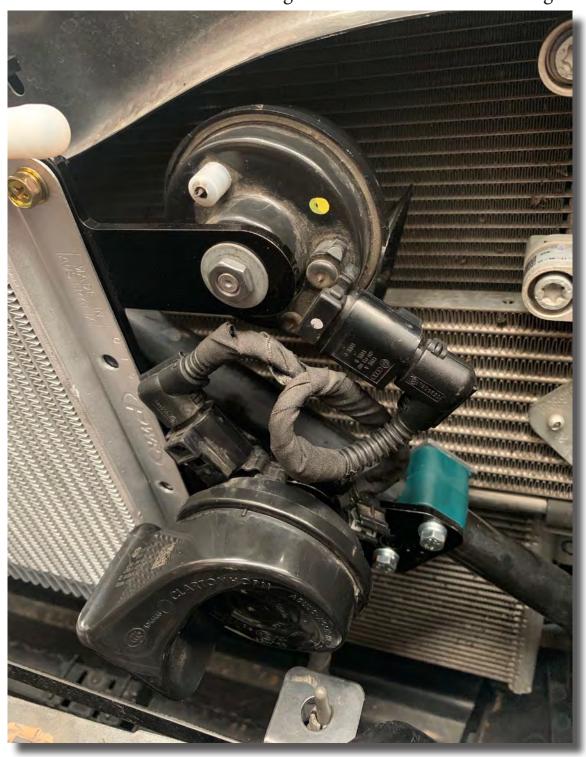
13. Mount horns to cooler bracket using original hardware. Upper horn mounts facing rearwards, lower horn mounts facing forwards. Ensure the orientation of both horns are facing downwards to avoid water ingress.

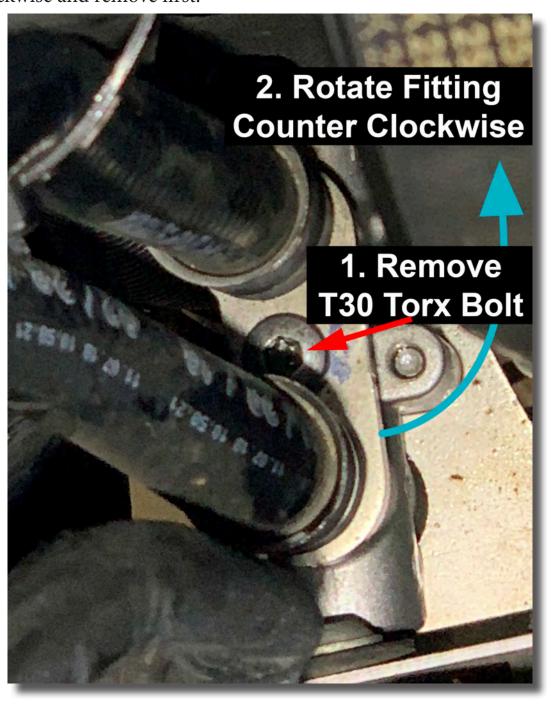
- Locate the top of the thermostat housing in engine bay directly in front of 15. serpentine belt.
- Remove the T30 torx bolt inbetween the two upper cooler lines, then 16. remove upper cooler lines. The line closest to the engine, twist counter clockwise and remove first.

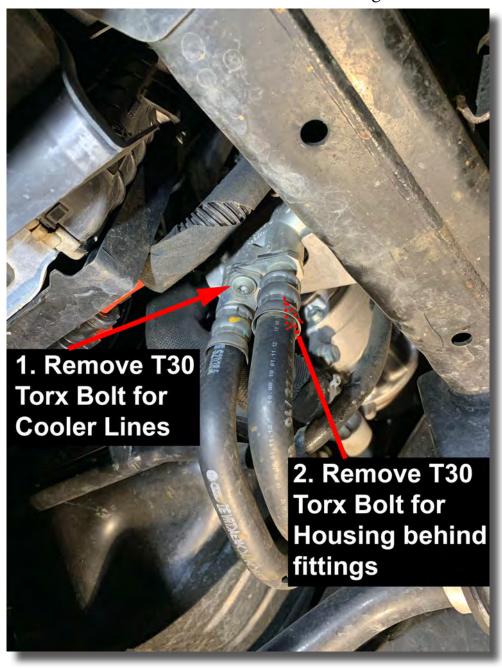
- 17. Under the vehicle, remove any bash plates that prevent access to the thermostat housing. The thermostat housing is mounted to the inside of the chassis rail, near the radiator and A/C compressor.
- Remove the T30 torx bolt that secures the two lower cooler lines, then 18. remove lower cooler lines. The line closest to the engine is removed first.
- Locate the second T30 torx bolt under the thermostat housing and remove. 19. This is the bolt that secures the thermostat housing to the chassis.

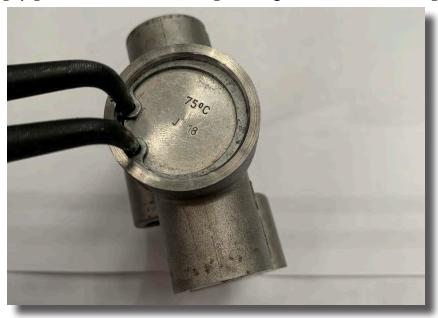
20. With the thermostat housing on the bench, using the circlip pliers and your fingers, apply pressure to the endcap enough to remove circlip.

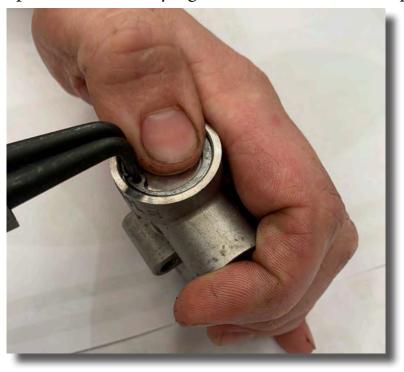
21. Slowly release the pressure on the endcap and allow it to come out. You may need to manipulate the endcap to get it to release. Keep your hand covering the endcap to prevent it from flying off due to the internal spring.

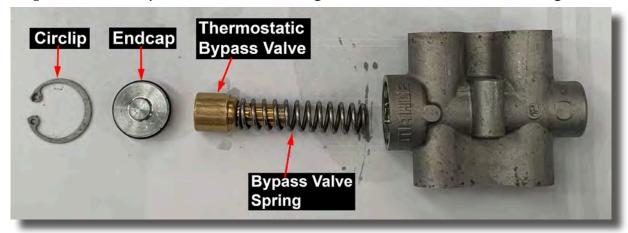
22. Remove the thermostatic bypass valve and spring. These are no longer required but may be saved if wishing to return to standard configuration.

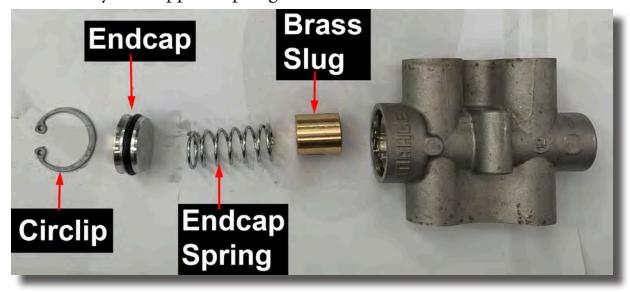
- 23. Replace endcap o-ring with supplied o-ring if it looks damaged in any way.
- 24. Insert into the now empty thermostat housing, the supplied brass slug first followed by the supplied spring.

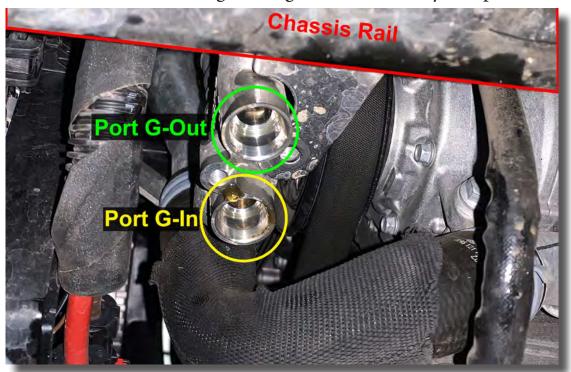
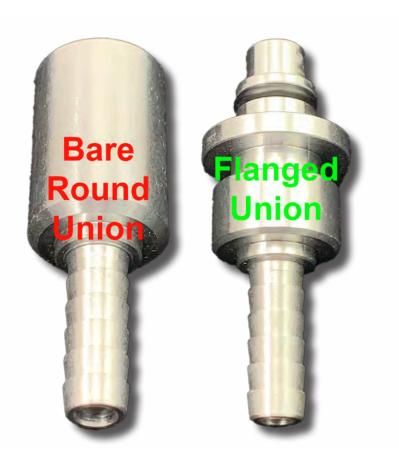
For the next step, please take note of the names of the following parts so that 27. it all makes sense. The changes being made are to only one port - G-Out.

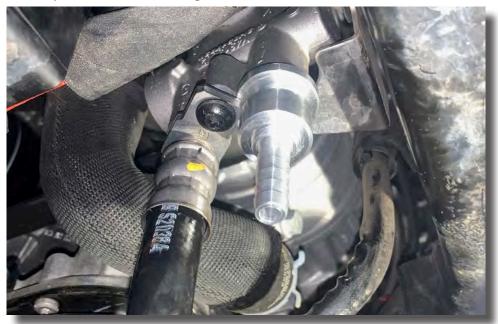
28. First install the Flanged Union into the port labelled G-Out. Insert the factory original fitting into the port labelled G-In. The flange on the orignal fitting also secures the Flanged Union in place. Secure with supplied T30 torx bolt only. Do not use original bolt.

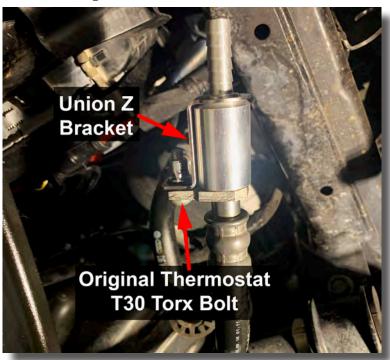
Insert original cooler fitting from port G-Out into the Bare Round Union. 29. Secure in place with supplied union Z bracket and original T30 torx bolt replaced in previous step.

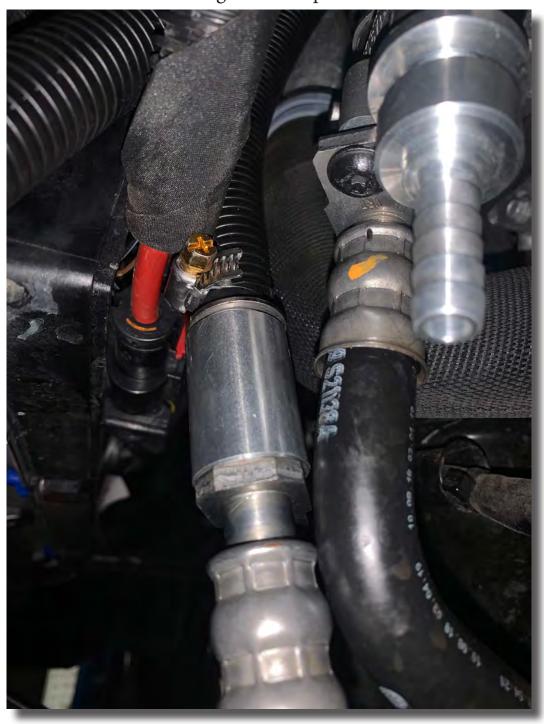
30. Route cooler hose from new cooler down to custom unions. Cut one side of the looped cooler line for the Bare Round Union (the cooler lines are multi directional - it does not matter which way it flows). This union will sit beside the thermostat housing once complete. Secure with screw clamp.

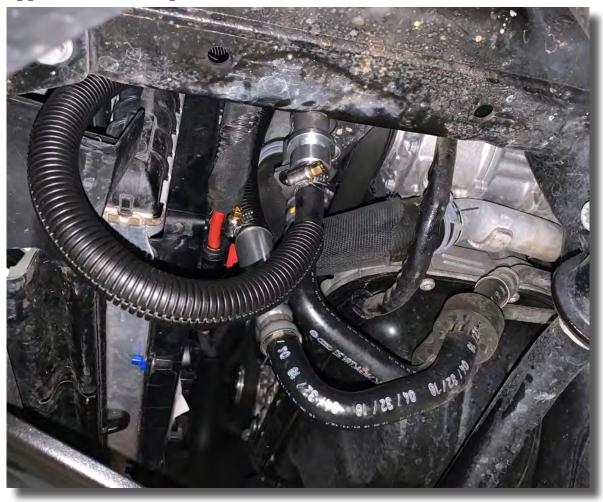
31. Fit the looped hose to the Flanged Union in port G-Out and secure with supplied screw clamps.

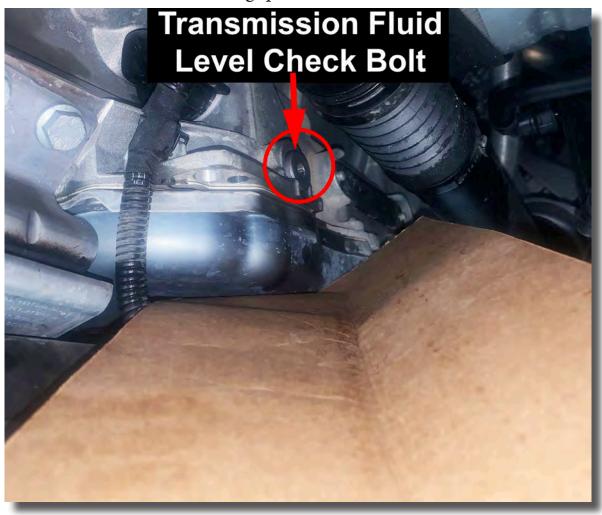
- Before installing front grill, please re-check all fittings are tight and that 36. there is no wiring touching the cooler.
- Re-install front grill by pushing the twelve (12) clips into factory bumper 37. first then secure using the two (2) T30 torx bolts and two (2) plastic clips.
- Have someone start the vehicle and ensure vehicle is in Park with 38. Handbrake firmly on and their foot firmly on the brake.
- To assist with cleaning, for the next step, cut some of the cardboard 39. from the box the cooler kit was transported in to create a funnel for the transmission fluid. This will prevent transmission fluid from ending up in the crossmember and creating quite a mess.

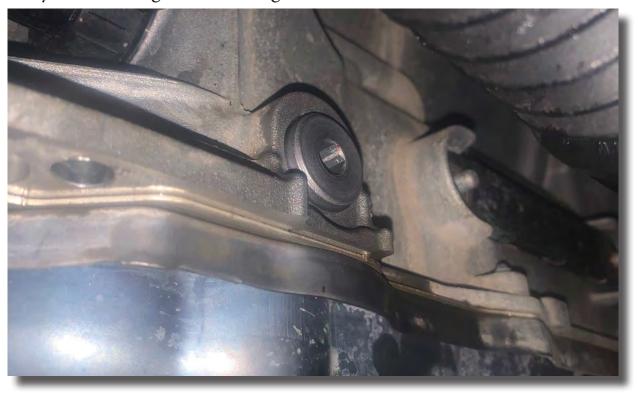
Locate transmission fluid level check bolt on the drivers side of the 40. transmission, just above crossmember. Remove using an 8mm Allan key only after the engine is running.
